Preliminary Report on the SS Wisconsin Archaeological Field Project, Summer 2015

By:
Caitlin Zant and Tamara Thomsen
Wisconsin Historical Society

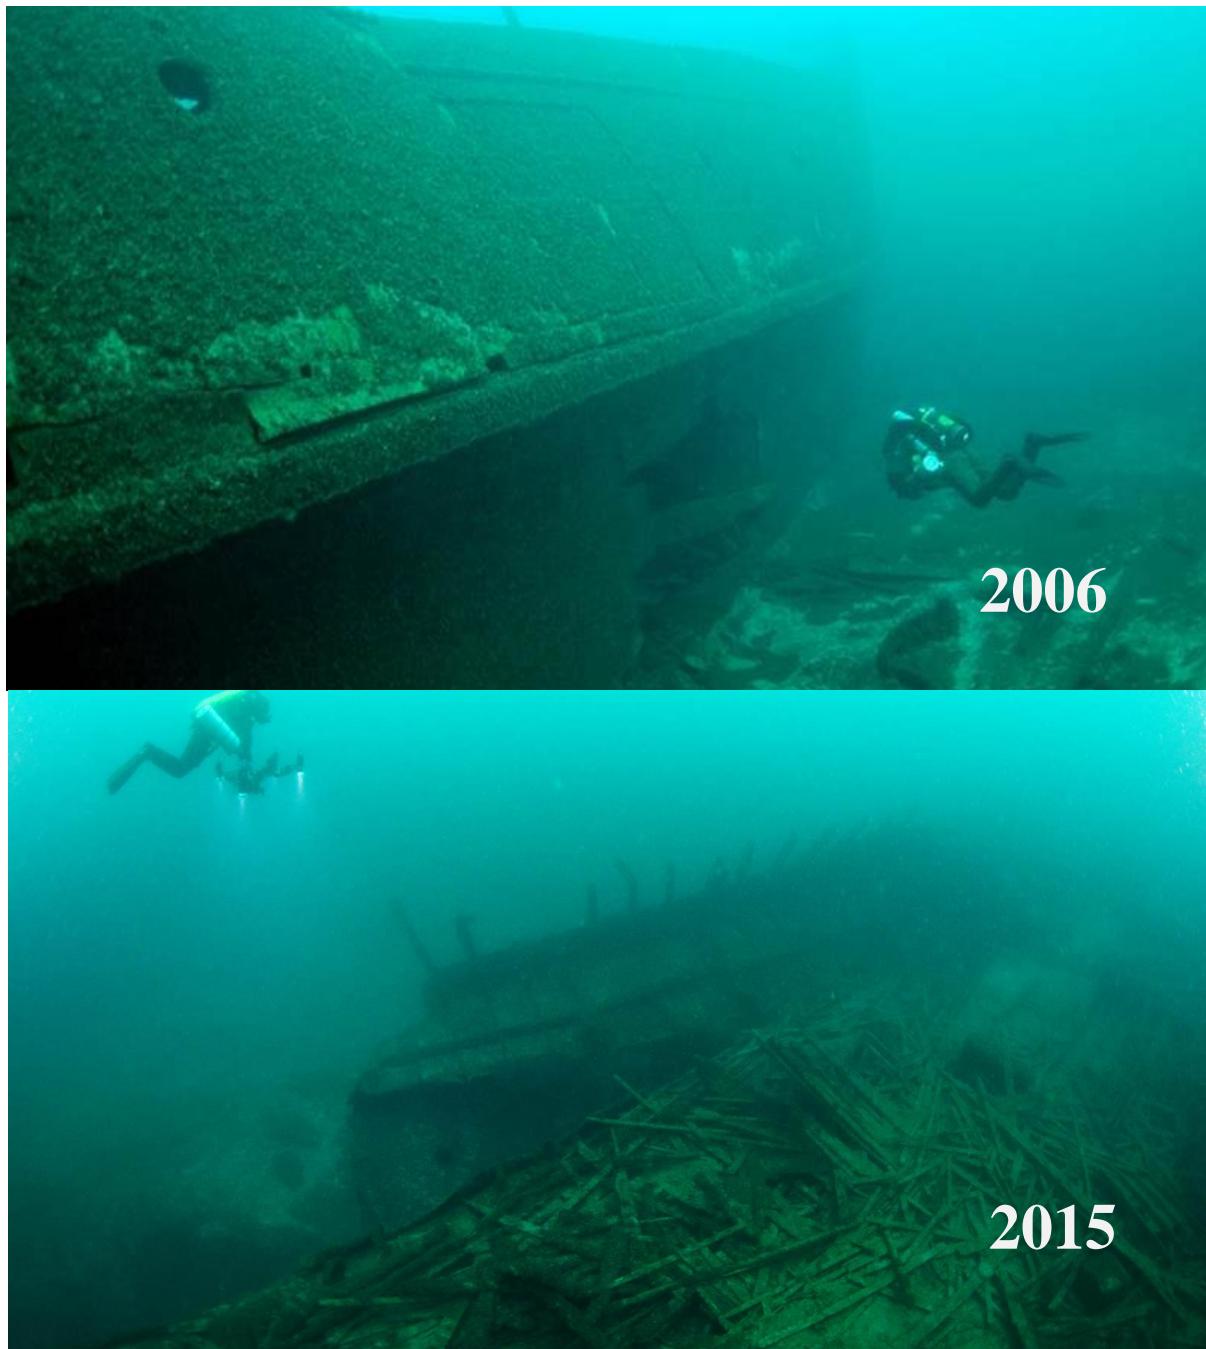
George Beyer, to collect new video data of the site for monitoring purposes. Upon the start of the 2015 survey, there were already major changes to the site that could be seen with the naked eye. A 65-foot long section of the side of the ship had fallen outward, where in the initial surveys of 2005/2006; it was attached, and seemed to be caving inward.

Figure 3: Photos of the Wisconsin's side intact in 2006 and broken in 2015 (Tamara Thomsen, Wisconsin Historical Society)

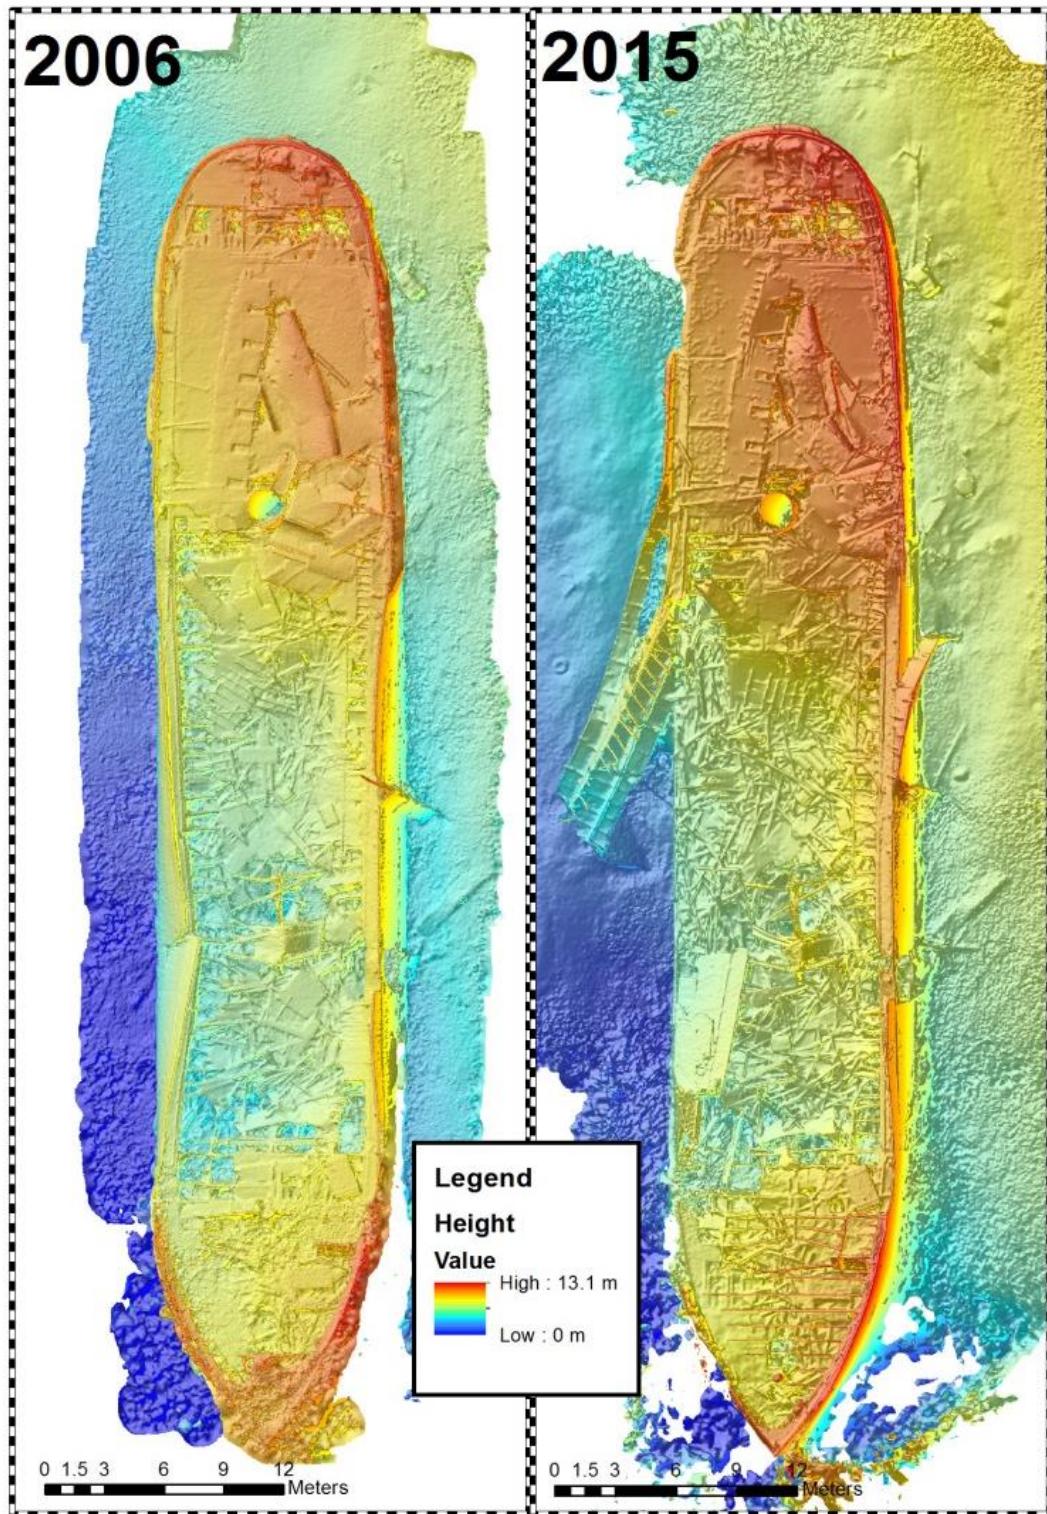
Figure 5: Side by side comparison of Wisconsin, 2005 & 2015 (Jordan Mertes, Jason Gulley, Michigan Technological University)

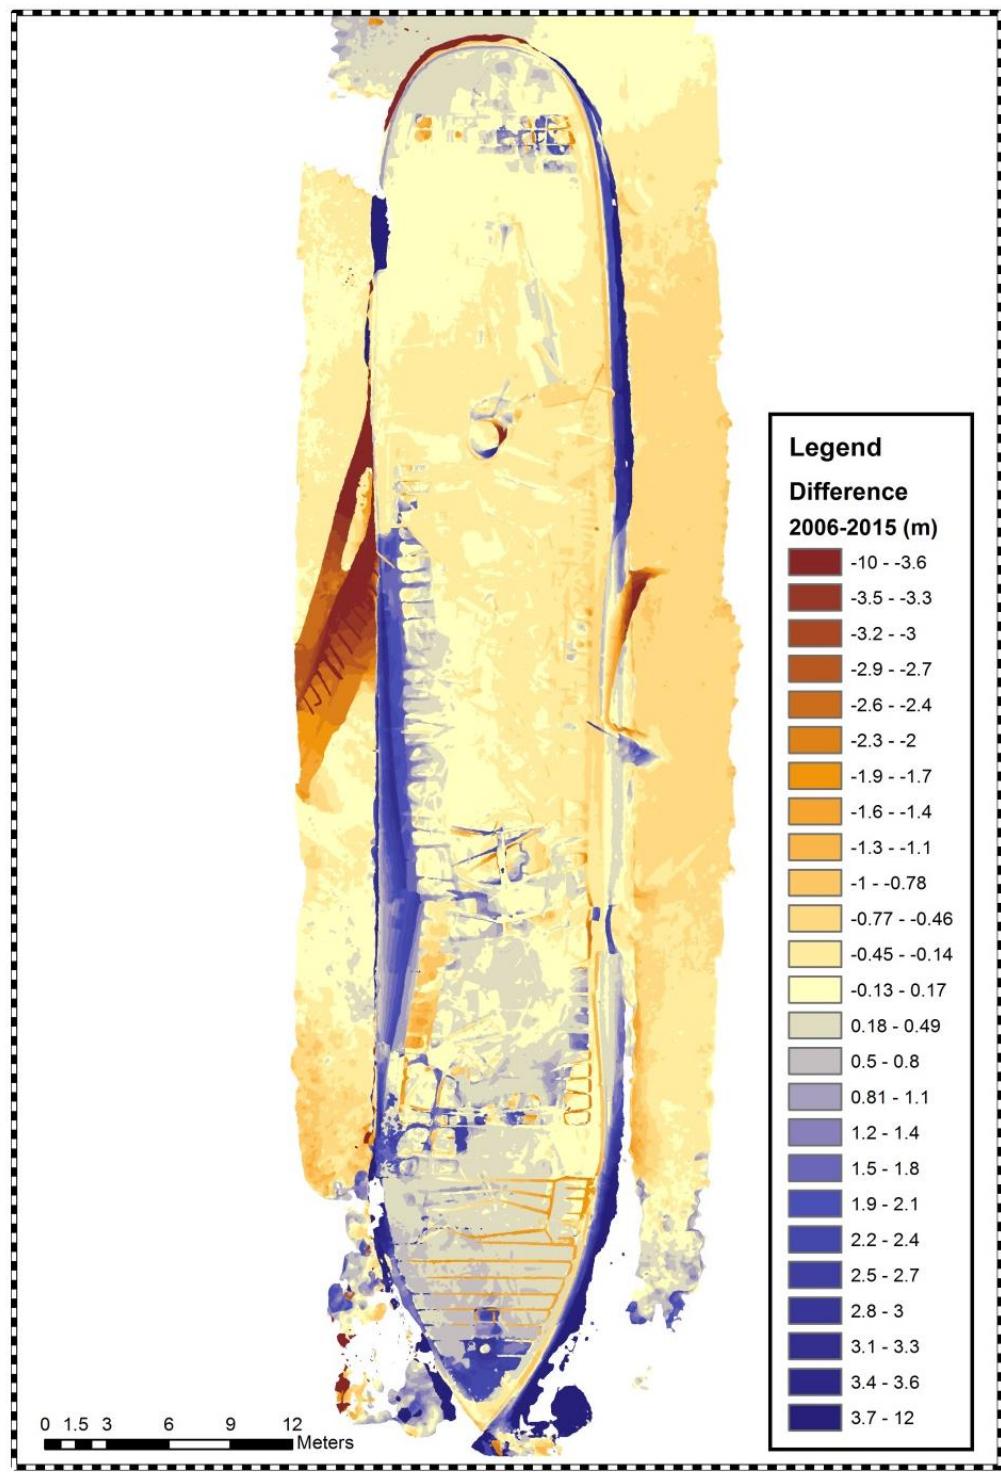
Figure 6: Change map of the Wisconsin, with amounts of change indicated: blue are areas of loss or collapse, and red are areas of gain (Jordan Mertes, Jason Gulley, Michigan Technological University)

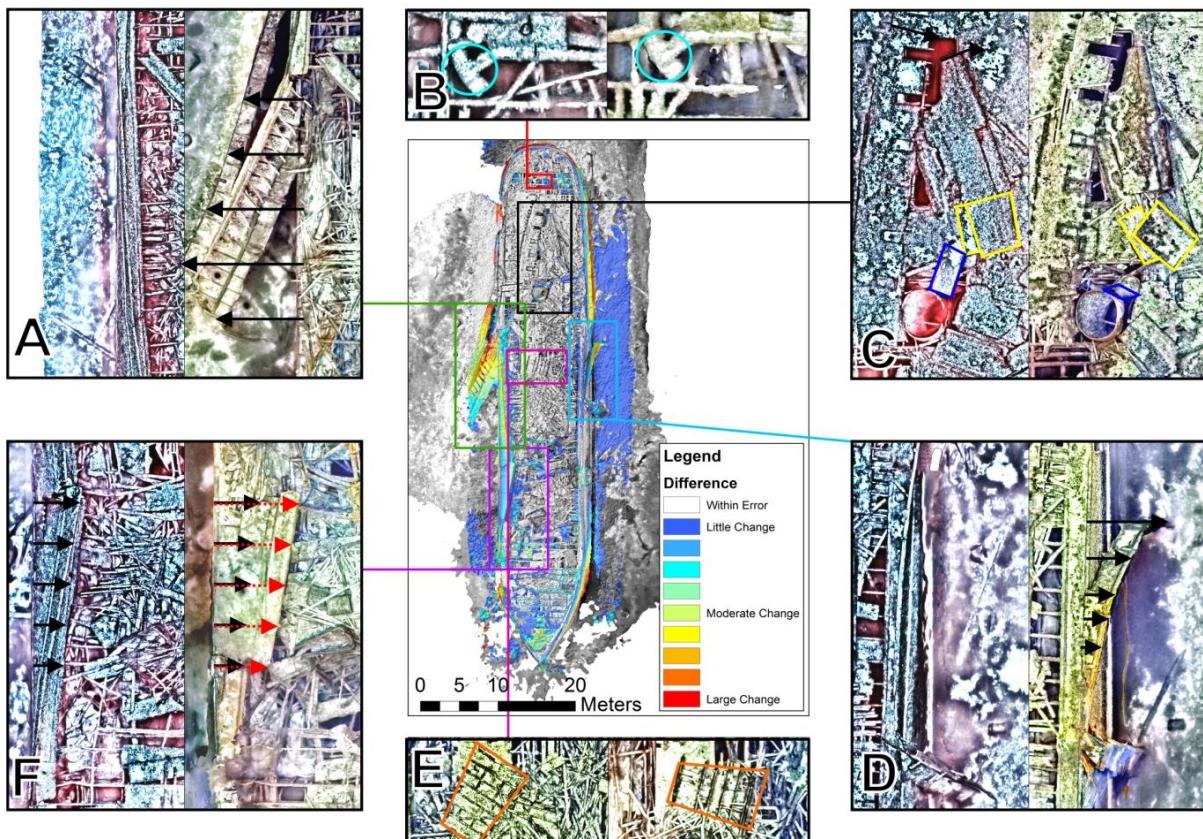
Figure 7: Map of the *Wisconsin* with large changes highlighted (Jordan Mertes, Jason Gulley, Michigan Technological University)

indicate that this pattern, however, is no longer evident. A 19.8 m section of the *Wisconsin*'s starboard hull, which had been leaning inward significantly in 2006, has fallen away from the main body of the wreck, hinged at the aft end (sub figure A). A 7.0 m long section of the hull, located just forward of this large section, has continued its collapse inward, creating a vertical crack along its forward edge, at the aft edge of the forecastle deck, and causing the collapse of previously intact forecastle deck beams (sub figure F). Additionally, a section of the vessel's main railing, which had remained intact in 2006, now hangs off the port side of the hull (sub figure D). The fantail stern of the *Wisconsin* has also shifted significantly further aft (comparison MapDif). This indicates that the *Wisconsin* is actively collapsing outward, not inward.

Although there is no direct indication as to why this is occurring at this site and not others, one possible explanation is that the buildup of a carbonic acid layer beneath the quagga mussels now inhabiting the site have added to the site formation processes already at work on the vessel. During the sinking event, the *Wisconsin*'s upper deck cabins blew off due to a sudden release of air trapped within its enclosed spaces. When this occurred, the integrity of the iron deck beams was compromised, and upon the vessel's collision with the lakebed, these beams and their support stanchions, collapsed inward along the ship's centerline (Thomsen and Meverden 2010).

This trajectory of inward collapse should have continued as increasing weight from the buckled upper decks was placed on the remaining deck stanchions in the lower hold of the vessel. The addition of mussels, however, has sped this process. Through a combination of weakened metal from carbonic acid buildup, increased water turbulence over the uneven surface of the mussels, and the sheer weight of mussel accumulation (in many places reaching 0.08 m in thickness) the thin iron covering the vessel's upper decks is cracking above the vessel's bustle, allowing the forces of wave, current (storm damage), and human (anchor damage) action to affect the vessel's typical degradation. The bustle refers to the 0.9 m sections on either side of the ship where it was widened in 1909. Historically, this was an area noted for leaking and weaknesses in the hull, and may be further indication of why the vessel is degrading more rapidly here than in other sections. Except for the small section of the vessel's fantail stern, the bow and the stern of the vessel have experienced very little overall change between 2005 and 2015. This is likely because these two sections retain their integrity from the original build of the vessel in 1881.
