**Wisconsin Coal Haulers:
Underwater Archaeological Investigations
from the 2012 Field Season**

**State Archaeology and Maritime Preservation Technical
Report Series #13-001**

Keith N. Meverden and Tamara L. Thomsen

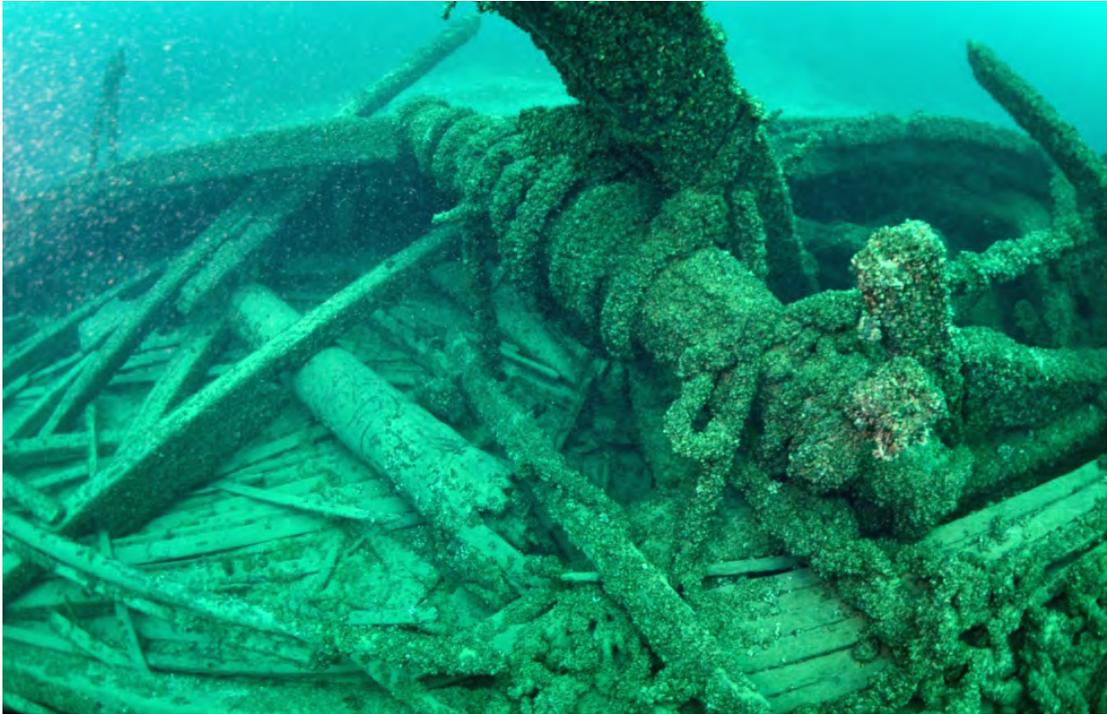
A large wooden bitt lies within the hull aft of the windlass on the starboard side. An iron norman pin penetrates the bitt near the top, and there is visible wear on the bitt from lines being tied to it and the norman pin. This bitt originally protruded from the weather deck aft of the windlass. The forecabin scuttle is intact, but has collapsed with the deck and now lies beneath the windlass. A quantity of anchor chain is piled on the weather deck aft and to starboard of the windlass.

Figure 3. Windlass with norman pins. Base of foremast lies on floors aft of windlass.

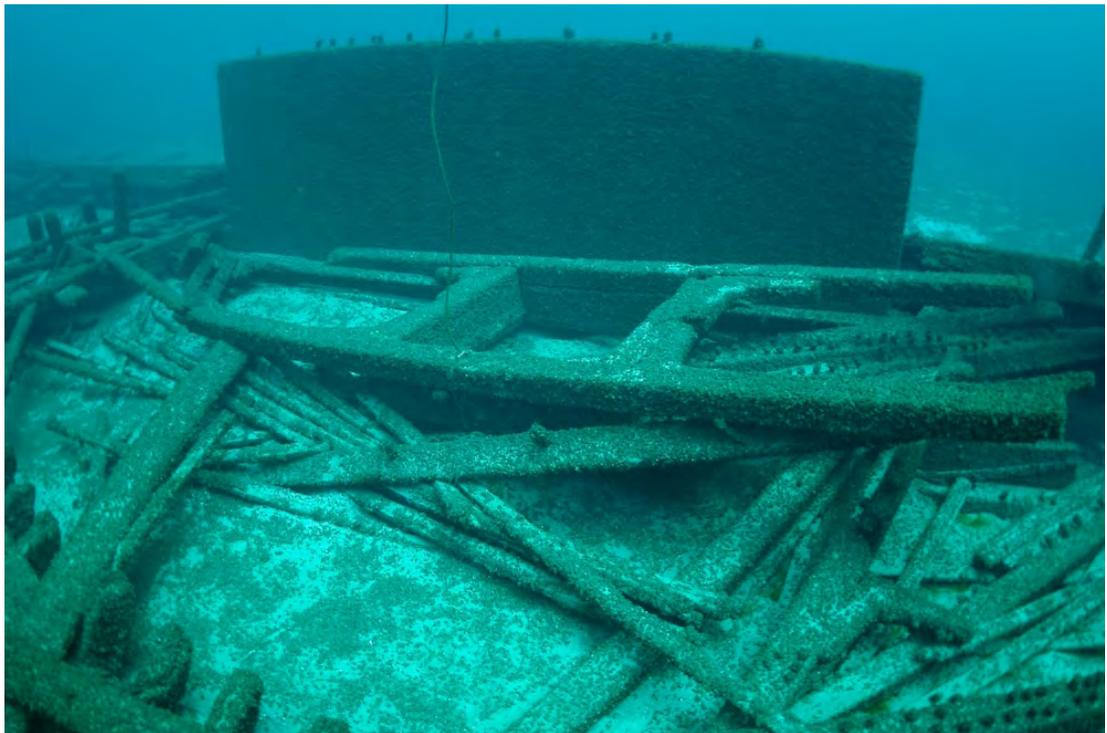
The weather deck has collapsed within the hull, and most of the deck is broken up with the exception of an area between the center and aft cargo hatches. The center cargo hatch has become disarticulated from the deck section and lies inverted to starboard of the centerboard trunk (Figure 4). An iron capstan remains attached to the forward end of these beams and rests upside down within the hull, holding the deck section off the floor of the hull.

Figure 4. The center cargo hatch lies inverted along the starboard side of the centerboard trunk.

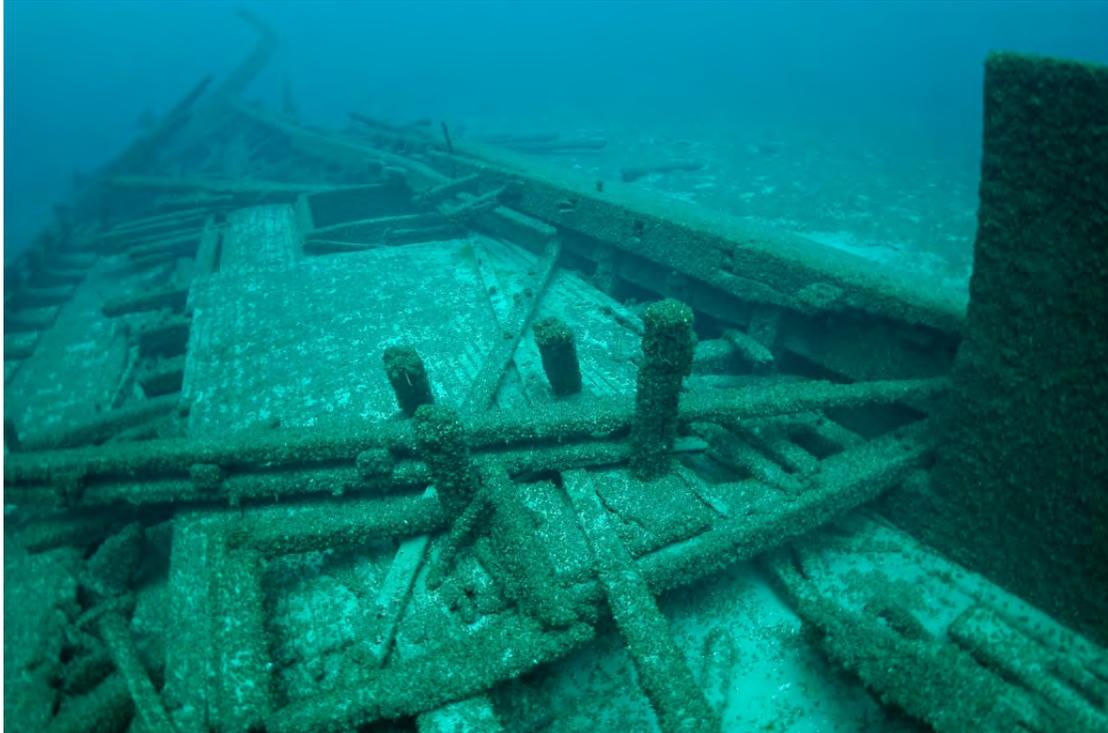
An intact deck section, from forward of the mainmast to aft the aftmost cargo hatch, lies within the hull aft of the centerboard trunk and to starboard of the keelson (Figure 5). The aft cargo hatch is 6.7 feet square on the outside of the coaming. The headledges are 1.9 feet tall by 0.3 feet wide and rise 1.3 feet above deck level. The coamings are notched on either side to produce a shoulder that extends 0.2 feet downward from the upper, inside edge of the coaming. Deck planks on this section are 0.35 feet wide by 0.2 feet thick. Deck beams are 0.9 feet sided by 0.6 feet molded, and have a space of 2.7 feet between beams. A double-acting bilge pump lies in the hull aft of the aft cargo hatch.

Figure 5. Section of intact deck from between mainmast partners to aft cargo hatch.

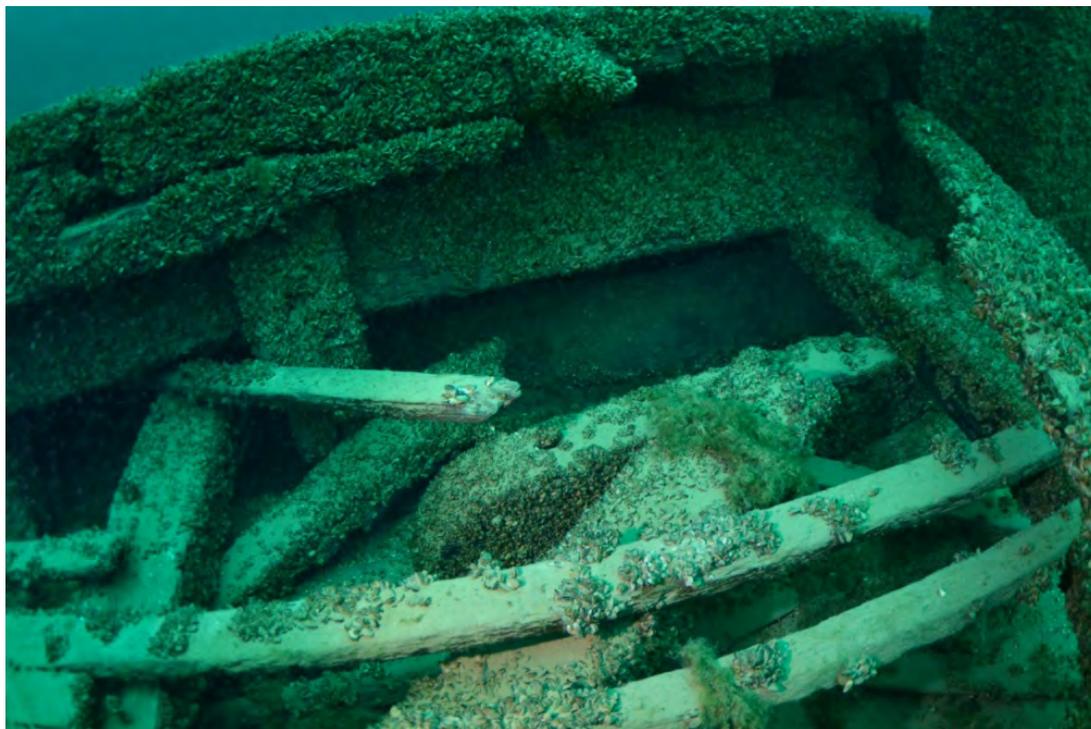
aft of the trunk. It is fastened to the starboard side of the keelson. Each of the timbers is 6.0 feet long, 1.1 feet tall, and 0.5 feet thick with a radiused end. They are fastened to the keelson with iron bolts.

Figure 6. Reinforcing timber fastened atop the starboard side of keelson, aft of the centerboard trunk. A similar timber is fastened forward of the trunk on the port side of the keelson.

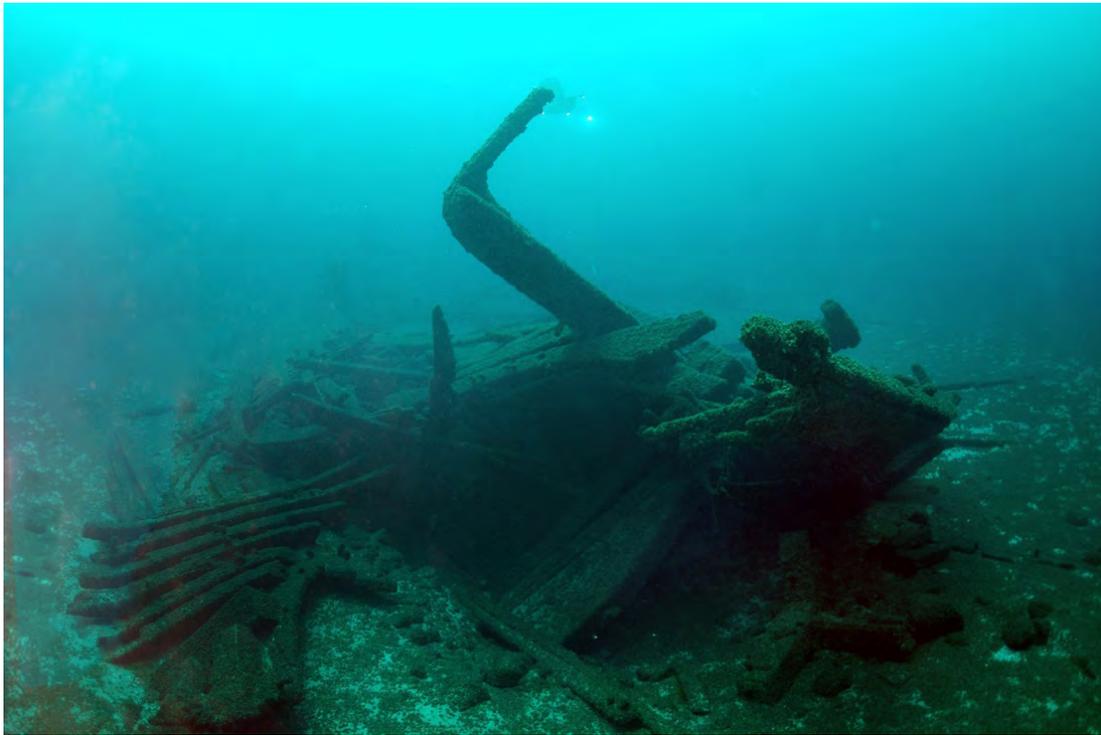
The sternpost lists 42 degrees to starboard and leans 26 degrees aft. The stern post is 1.1 feet sided, 0.8 feet molded, and 13.4 feet in length. The rudder blade is 10.3 feet tall and 3.0 feet in length at its widest point, curving forward near the bottom of the blade. The rudder is dislodged at the bottom gudgeon. The fashion timber is 23.3 feet in overall length port to starboard, and constructed from a timber that is 1.45 feet molded by 1.55 feet sided. The vertical timbers fastened to the ends of the fashion timber are 4.0 feet tall by 0.4 feet square.

The transom remains connected to the fashion timber on the starboard side, but the port side of the transom has separated from the fashion timber and has fallen away from the vessel (Figure 7). The transom is 22.4 feet in width and has a camber of 1.7 feet, measured at the transom's centerline. Four planks are extant on both the inside and outside of the transom. Individual planks on both the inside and outside are 0.7 feet wide by 0.15 feet thick. The vertical stern timbers within the transom are 3.4 feet tall. The traveler for the mizzen sheet block is 1.2 feet in length and 0.2 feet in diameter, and the double sheave block remains attached to the traveler. The transom rail is 0.6 feet wide by 0.3 feet thick. There are two iron fairleads fastened to the top of the rail on either side of the transom, 1.2 feet inboard from either quarter. Each of the fairleads is 1.8 long, 0.4 feet wide, 0.3 feet high and has a 0.2-foot opening for lines.

Figure 7. The *America*'s stern, viewed from off the port quarter.

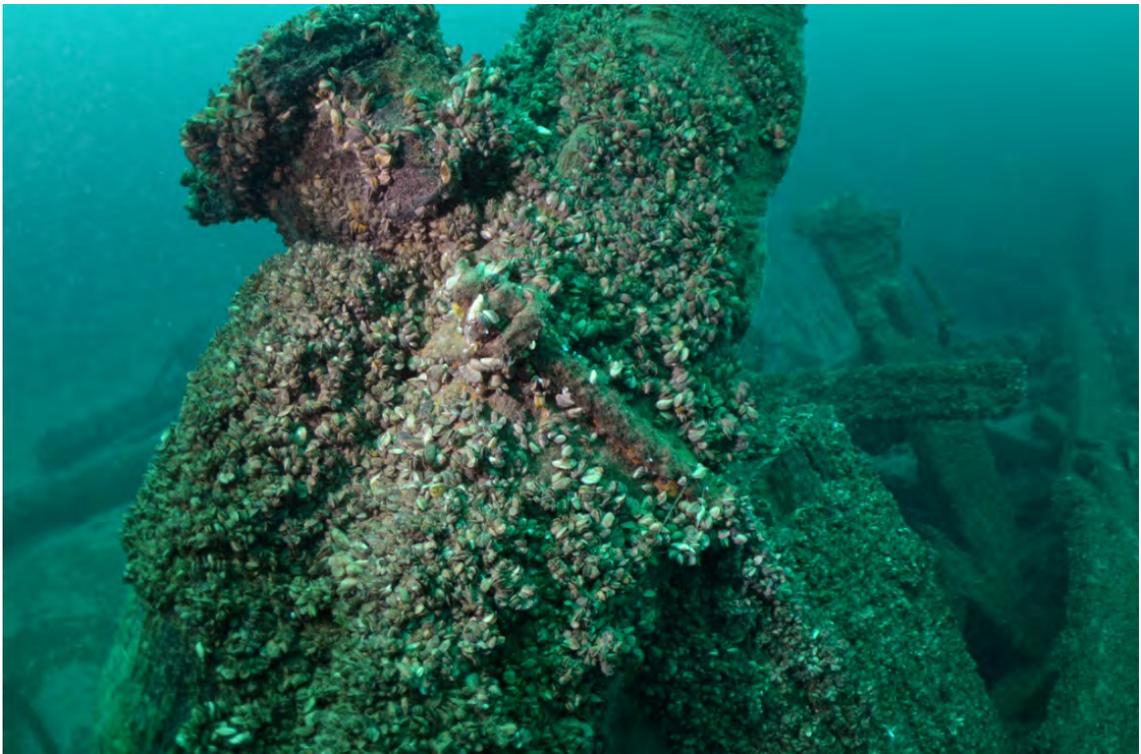
To allow quick raising of the bowsprit, a removable iron clamp held the bowsprit to the top of the stem (Figure 9). The clamp consisted of an iron bar placed over the top of the bowsprit that was secured with an iron bolt on either side of the stem. Each bolt is 2.2 feet in length, and the top of each bar is threaded to accept a square iron nut. The two nuts allowed tightening of the clamping bar to hold the bowsprit securely to the top of the stem assembly. To raise the bowsprit for canal lock passage, the bowsprit's standing rigging was disconnected, the stem clamp loosened and removed, and the head of the bowsprit was then hoisted upward until the bowsprit stood nearly vertically from the front of the samson post.

Figure 9. The bowsprit was fastened to the stem with a removable iron clamp.

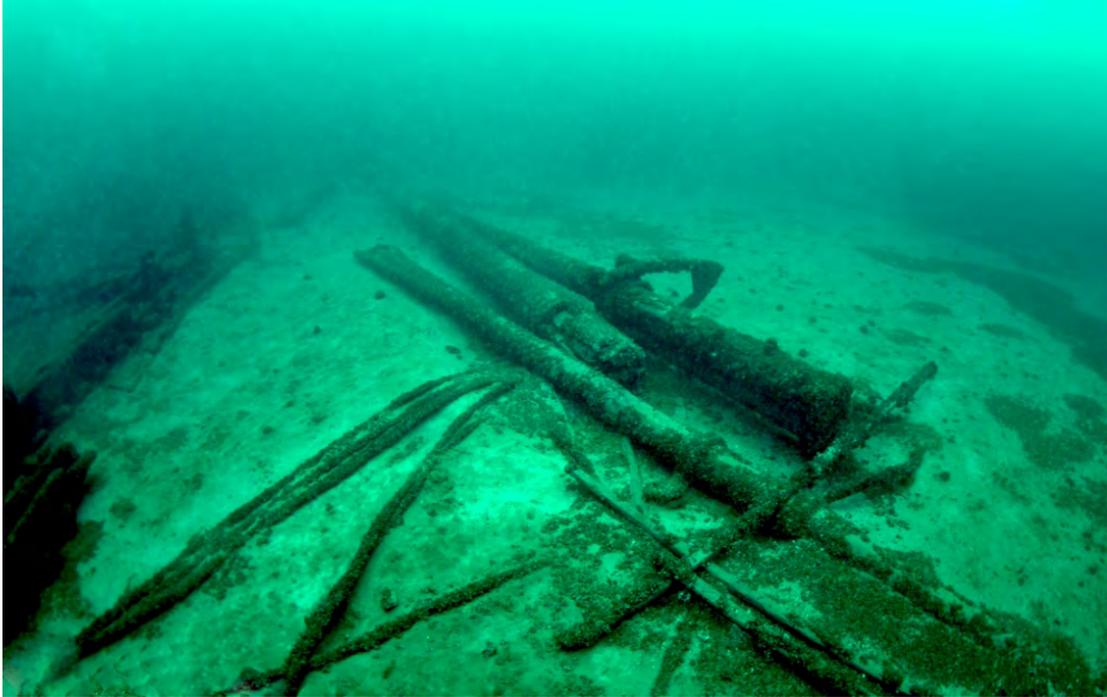
The mizzenmast is the southernmost of the masts and lies parallel with the hull with its masthead facing west (Figure 10). This mast is 1.2 feet in diameter at the break, and 63.3 feet in length from the break to the masthead. The mast's top is located 53.0 feet above the break and is constructed from two swept cross trees that meet at each end to form an oval-shaped top with sharp ends. The topmast remains stepped to the mast, but is broken just above the masthead level. A number of wire shrouds remain connected to the masthead and extend toward the wreck's starboard quarter.

Figure 10. View of the mizzen- and mainmasts, looking forward from off the starboard quarter. The mizzenmast is on the right.

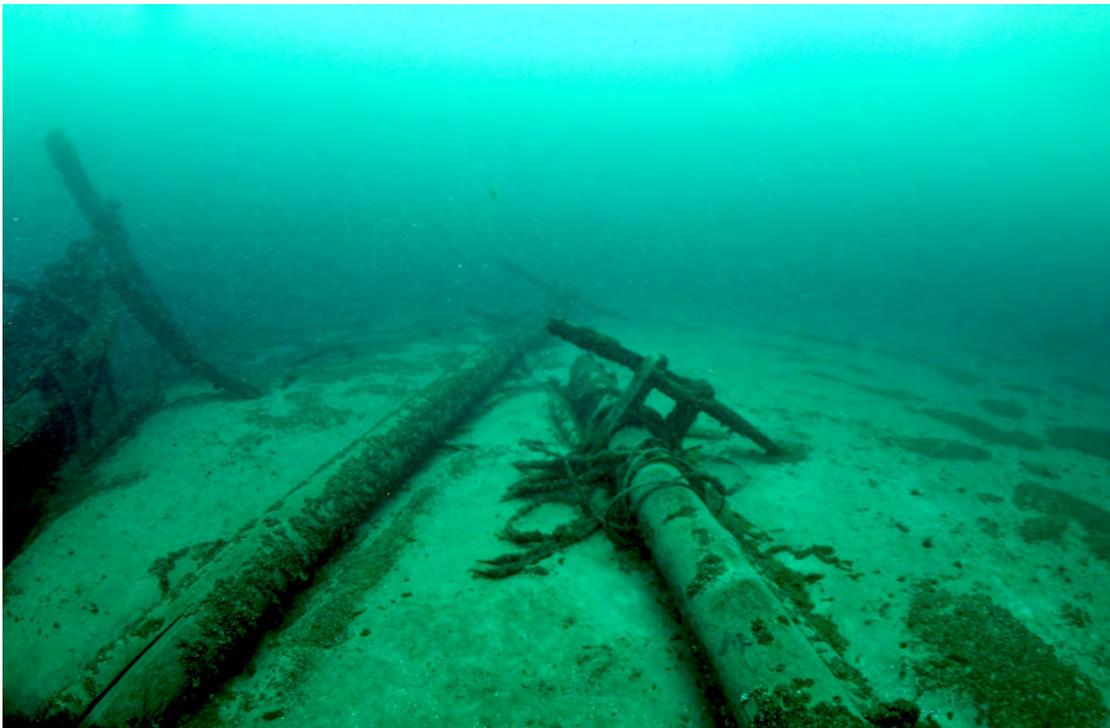
Figure 11. Fore- and mainmasts, looking forward from approximately amidship. The mainmast is on the right, and the bow is visible on the left. Wooden sail hoops are visible on the mainmast beneath the hounds.

The foremast lies between the hull and the other two masts, but somewhat eastward of the other spars (Figure 11). The foremast is 67.3 feet in length from the break to the masthead, and 2.5 feet in diameter at the break. The fore topmast remains stepped to the foremast, but has broken above the foremast's masthead and the upper portion now lies beneath the foremast. Both of the top's crosstrees remain attached to the trestle trees, and both are nearly straight with only a slight sweep aft. Several wooden sail hoops remain extant around the mast below the cheeks. A second boom is located off the port bow that is 43.9 feet in length.

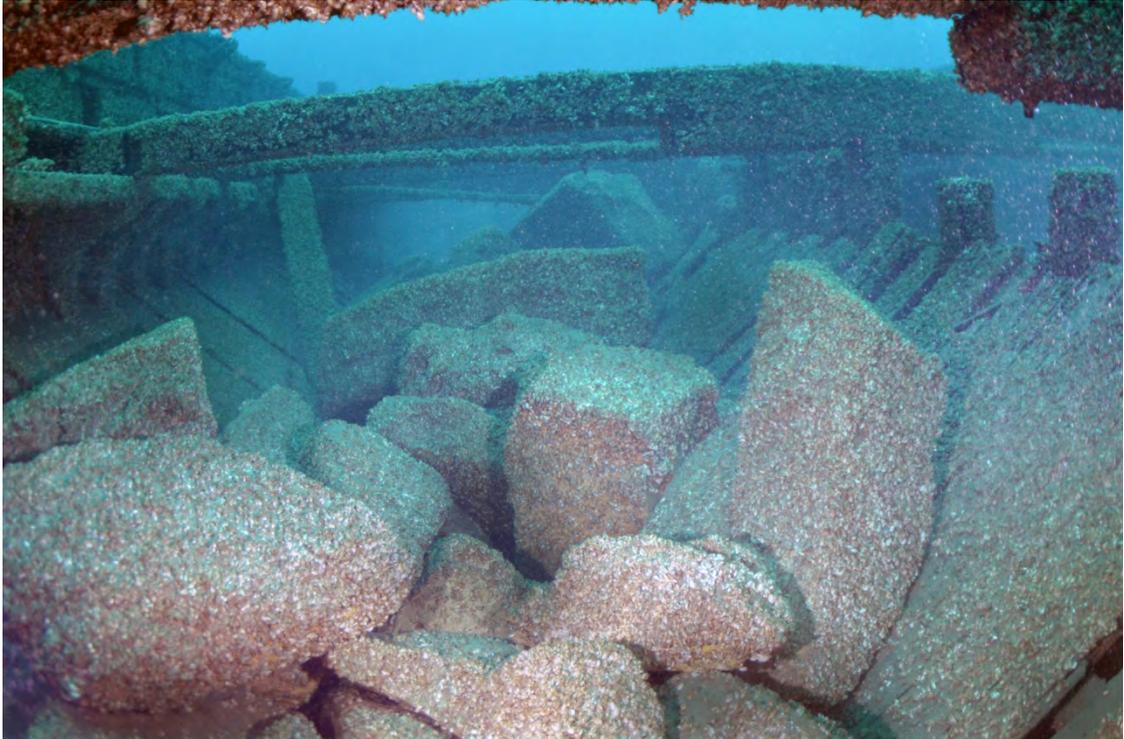
A number of large rocks lie within the cargo hoppers beneath the deck beams (Figure 16). These rocks are much too large to be handled by the self-unloading gear, which was designed to handle small diameter bulk cargoes such as coal, sand, or gravel. These rocks were most likely added as ballast to ensure a proper scuttling of the abandoned hull.

Figure 16. Large rocks now fill much of the cargo hoppers.

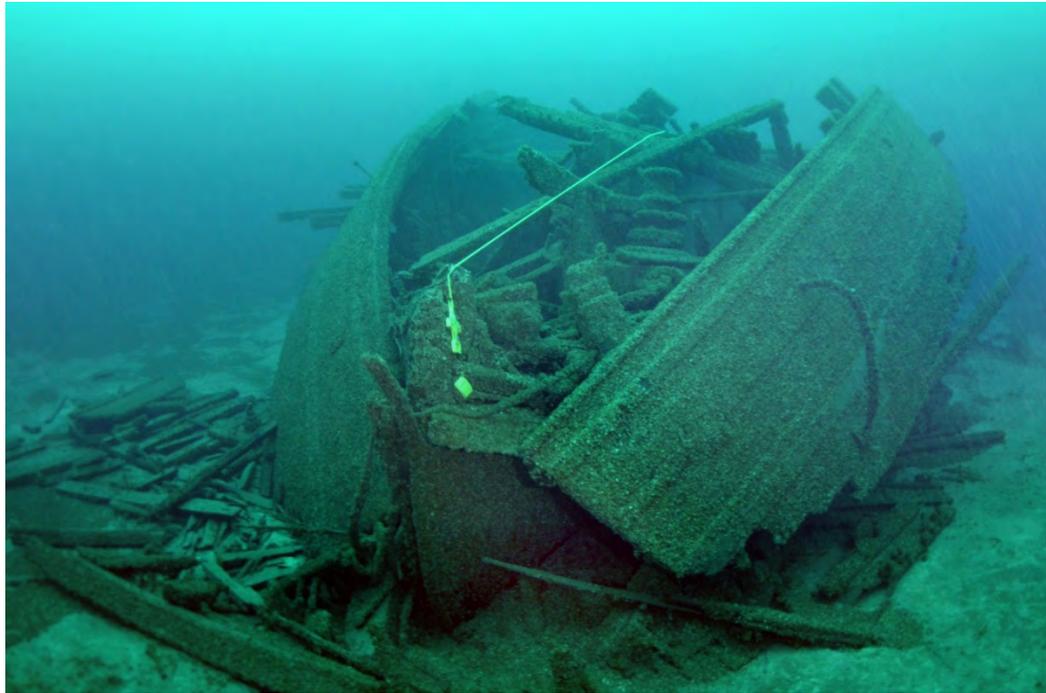
The bow is the only part of the hull that exhibits structural damage (Figure 17). The collision with the bottom broke the stem and cant frames at the waterline, dislodging a section of hull on either side of the bow. A large steam-powered windlass was fastened to the forecastle deck for handling ground tackle, but the forecastle deck has collapsed and the windlass has fallen into the forecabin and now lies on its end in the port side of the bow.

Figure 17. Broken bow with collapsed windlass deck.

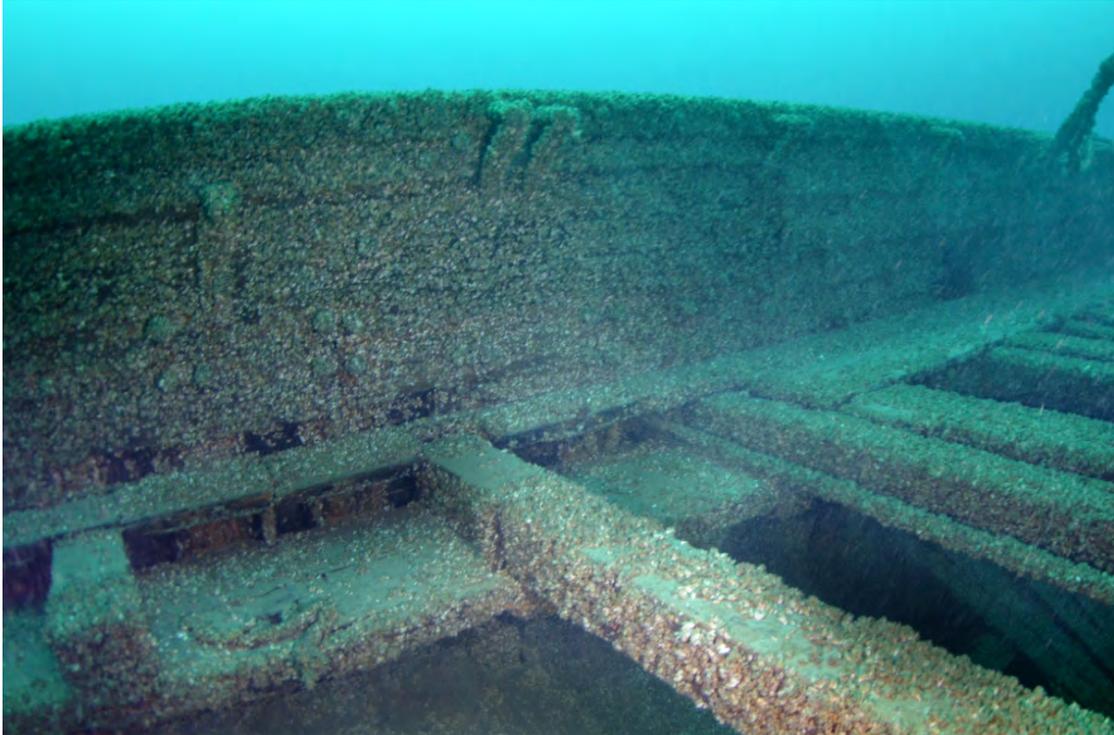
Figure 19. Deck beams have been removed throughout the hull. Looking to port at approximately amidship.

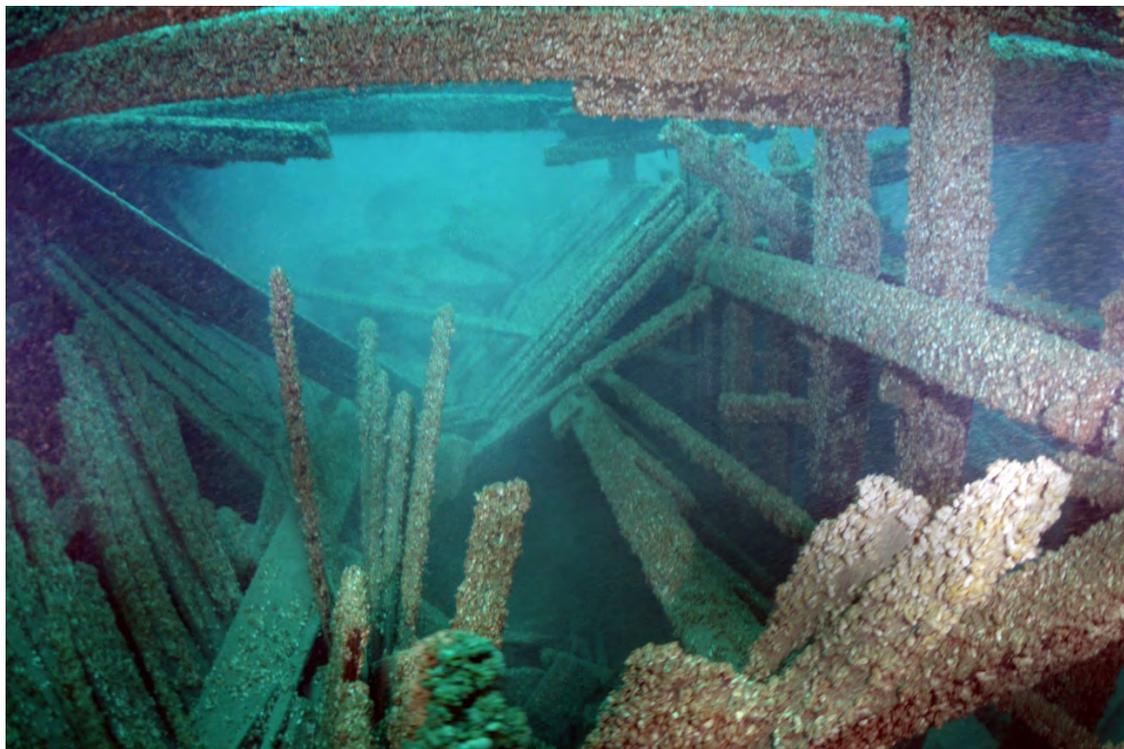
Figure 21. Collapsed section of port side hopper showing longitudinal timbers fastened to deck stanchions. Approximately amidship on port side, looking forward.

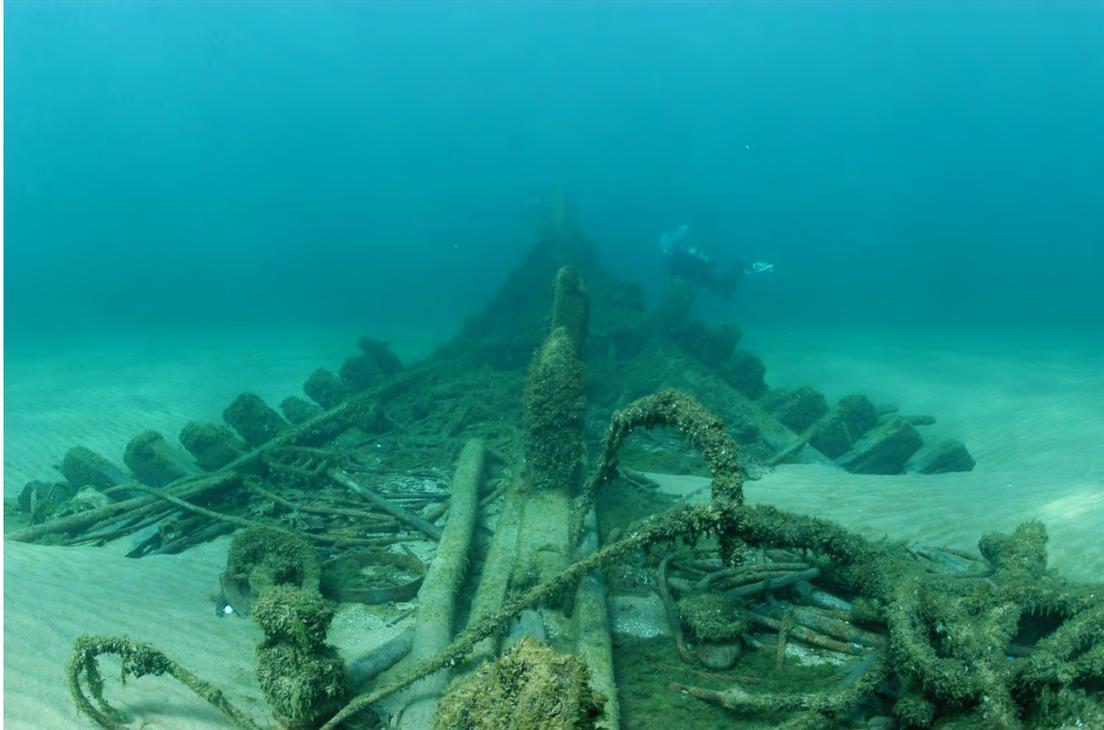
Just over 40 feet of the vessel's bow is exposed from the stem aft (Figure 31). The bow section possesses the greatest relief of all the site's features, as the stem rises to within 5 feet of the water's surface. A little over one foot of sand had vacated the bow section prior to the archaeological survey, which exposed the myriad of pipes, cables, and burned or melted ship parts lying within the hull structure.

Figure 31. Exposed bow section, looking forward along keelson.

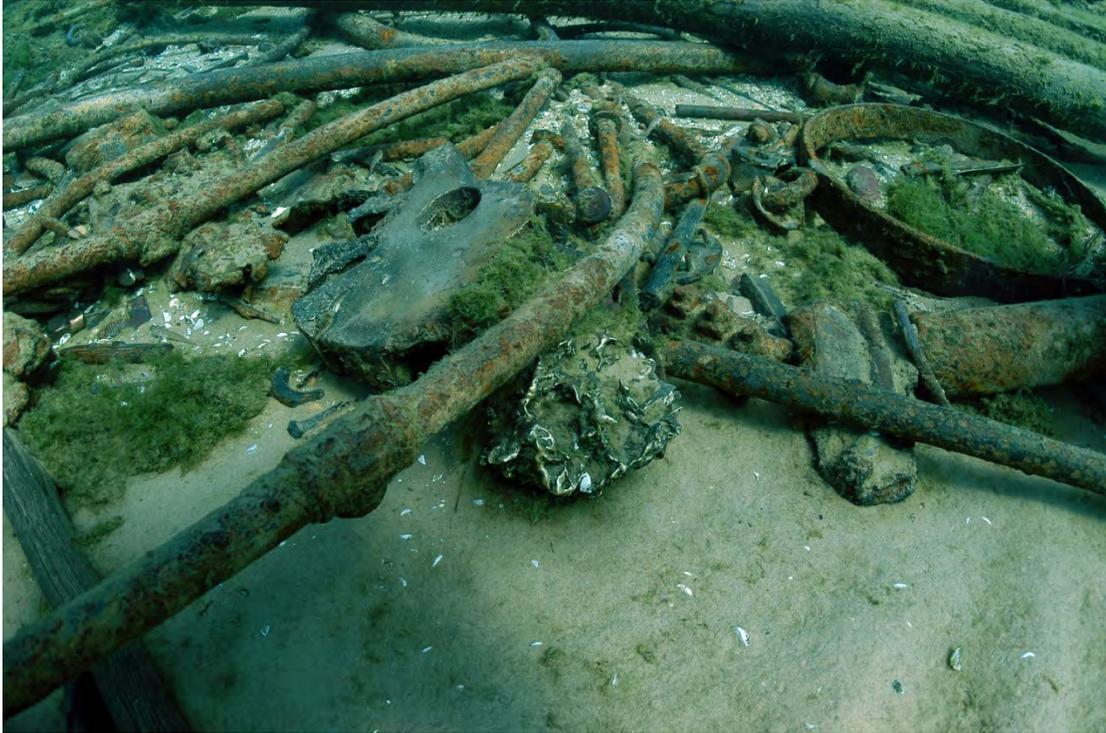
On the bow section, the outer hull planks are 0.3 feet thick but vary in width between 0.55 and 0.65 feet. The bow planking was protected by iron sheathing that consists of plates one quarter inch thick that are fastened to the outer hull to just above the waterline. The bow is double framed, with each frame futtock measuring 1.0 foot molded by 0.5 feet sided. Ceiling planks vary in width between 0.75 and 1.0 feet wide and 0.35 feet thick. All hull components, with the exception of the sheathing, are fastened together with iron bolts that pass through all hull timbers and fastened on either end with roves. A large amount of melted brass is dispersed throughout the bow structure (Figure 32).

Figure 32. A large amount of melted brass lies within the bow section.

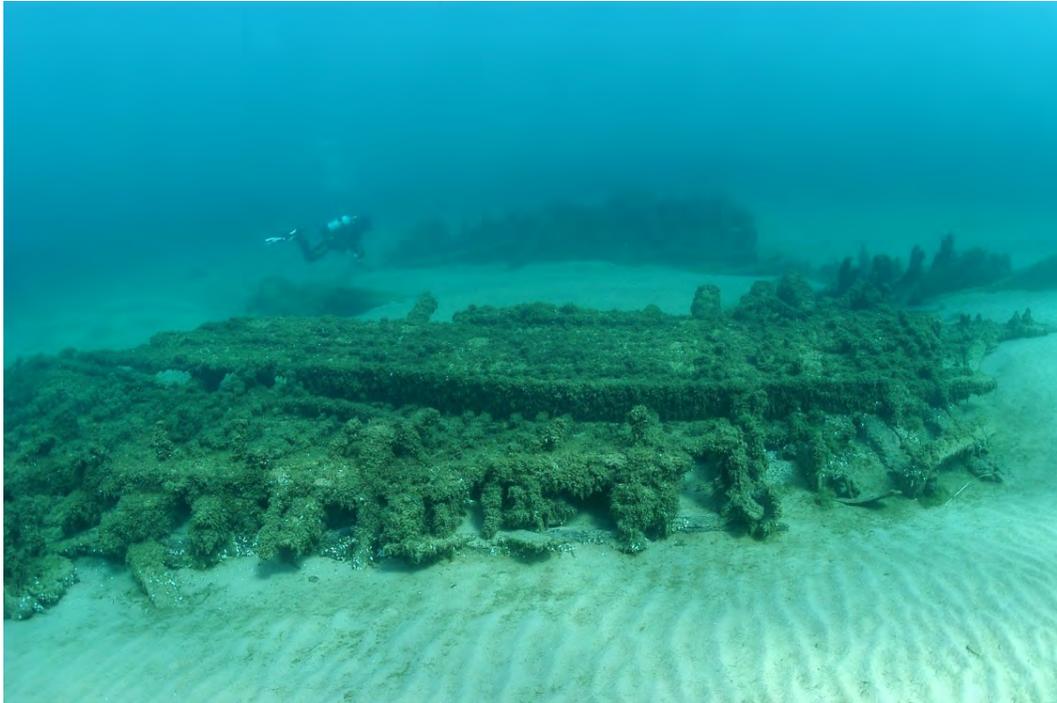
Approximately 75 feet of the stern is exposed from the sternpost forward, with portions of both the port and starboard sides visible (Figure 33). To port, the hull side is extant to nearly the weather deck, but has broken at the turn of the bilge and fallen outward. The starboard side remains attached and upright, but is burned away to approximately the waterline. None of the keelson assembly is visible on the stern section, and only the shaft log, main bearing, and engine mounts protrude from the lakebed. The vessel's propulsion machinery was thoroughly salvaged, including the engine, thrust bearing, propeller shaft and wheel, pumps, condensers, and associated plumbing of the engine room. The machinery spaces are now filled with sand and various parts including small pipes, fittings, and fasteners that fell loose as the surrounding wood was burned away. The former location of the boiler room is readily identified by sections of iron plate that lined the boiler room and protected the hull from the heat of the boilers. Forward of the boiler area, very little of the hull is visible with the exception of a very small section of the starboard side and a few feet of the port side deck shelf.

Figure 33. Exposed stern section, viewed from port side. Diver is above boiler room floor on vessel's centerline.

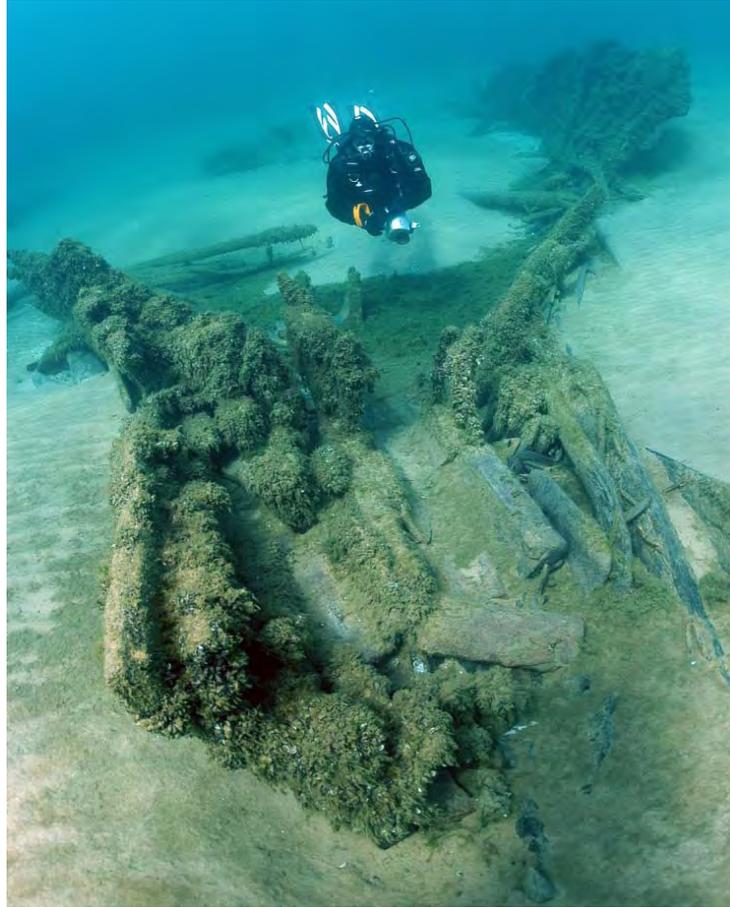
Both the stern post and the inner sternpost are extant below where the propeller shaft formerly passed through them, and both timbers are 1.6 feet molded (Figure 34). A lead packing is extant between the sternpost and inner sternpost. The bottom half of the shaft log is extant forward of the inner sternpost and is 5.9 feet long and 1.9 feet wide. The shaft log was constructed from two horizontal timbers, an upper and lower, that were fastened together. The upper timber was removed from the lower half, but it remains within the hull and lies next to lower half of the shaft log on the port side. The shaft log was lined with a bronze bearing, and fragments of bearing remain in and around the shaft log. The lower half of the shaft log is bolted to the timber below it with iron bolts and clinch rings on either side of the shaft bearing. The main bearing is extant forward of the shaft long and is 1.0 foot in length and secured to the hull by four threaded bolts that are each 1-3/8 inches in diameter and fastened with octagonal nuts that are 2.5 inches between lands. The upper half of the main bearing was unbolted by salvors in order to remove the propeller shaft, and neither the upper half of the bearing nor the propeller shaft is extant. Measured from the main bearing, the propeller shaft was 0.9 feet in diameter.

Figure 34. Vessel's stern, looking forward. Stern post is obscured by sand and algae, but shaft log is readily visible.

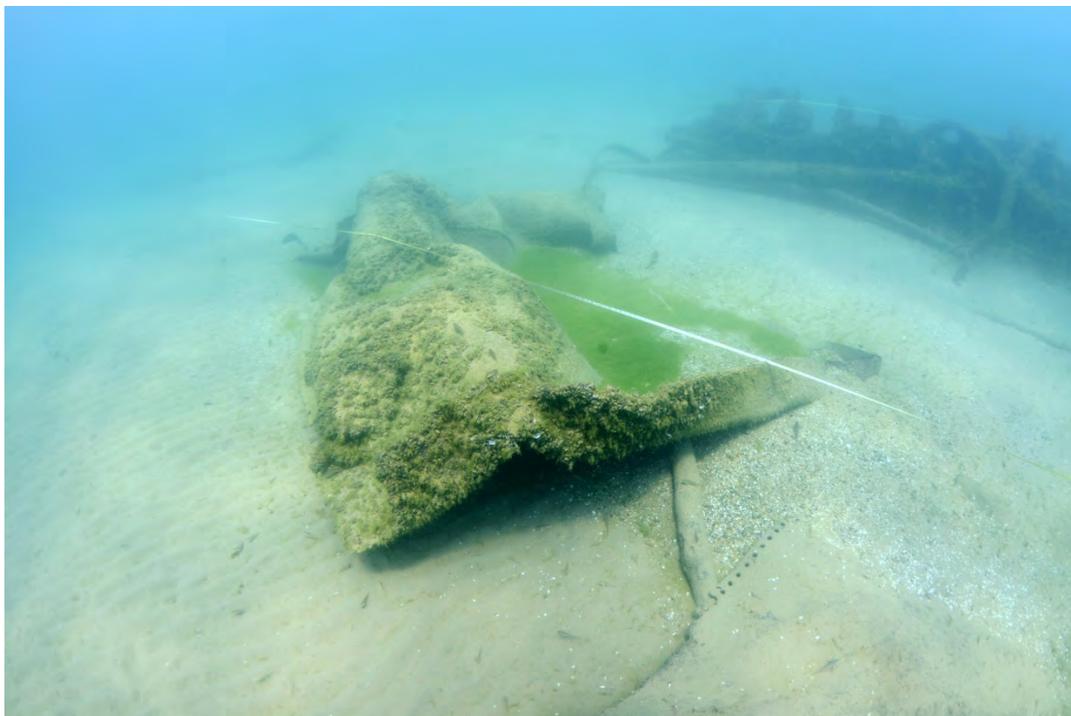
Figure 35. Remains of the boiler room bulkheads and floor. Section of upright starboard hull is visible in background.

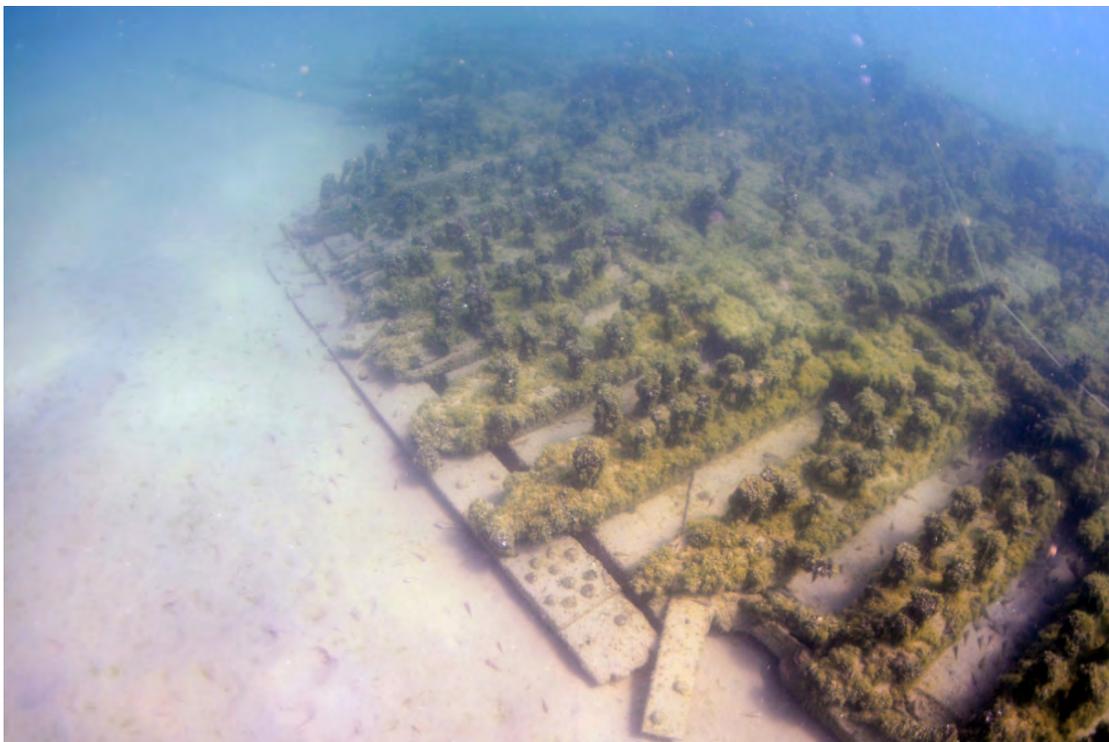
In most places on the port side hull section, the inner surface of the ceiling planks have burned away to leave only a very thin remnant of the original plank. This reduction in thickness leaves a large number of iron bolts protruding several inches from the hull side.

Figure 36. Port side hull has fallen outward. Hogging arch and basket truss system are visible between frames and outer hull planks. Note burned away ceiling and frames that have exposed iron bolts.

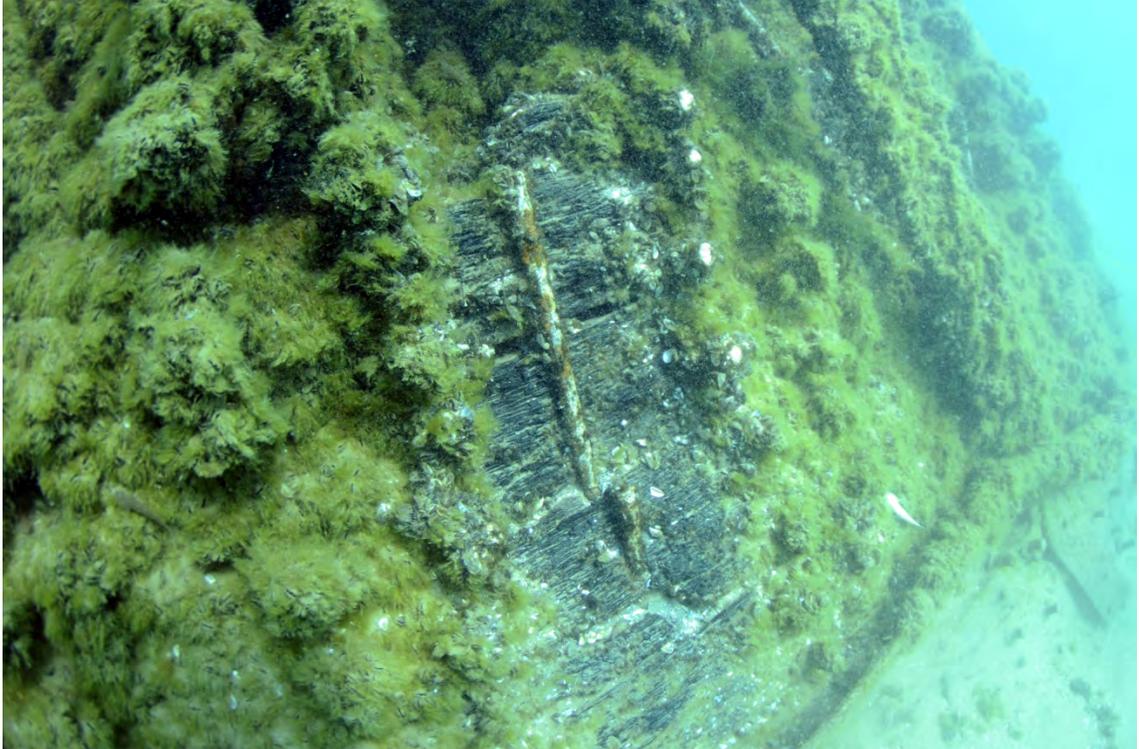
A small section hull protrudes from the sand forward of the boiler room bulkhead. Sections of basket truss that are visible indicate this is a section of the starboard side hull that has fallen inward. There is no evidence of burning on the outer hull planks that are visible.

Figure 37. Starboard side hull remains upright, but has burned away to reveal edge-bolts within the ceiling planks.
