Scow Schooners: A Regional Analysis

Final Report and Documentation

Final Report: Project Number 2020-002

**WISCONSIN
HISTORICAL
SOCIETY**

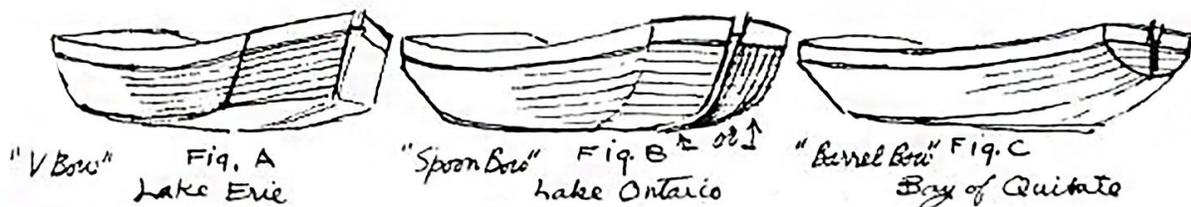
Figure 1. Various scow bow structures (Loudon Wilson).

Despite occasional disputes over identification, scows have several unique characteristics which can be used to differentiate them from conventional vessels. These traits are most easily understood when analyzing the hull. Scow hulls are boxy with a flat bottom and vertical sides, connected by a hard chine, or a nearly ninety-degree angle at the bilge. Conventional sailing vessels, whether flat-floored or with deadrise, possessed a soft chine, or a smooth, rounded edge.

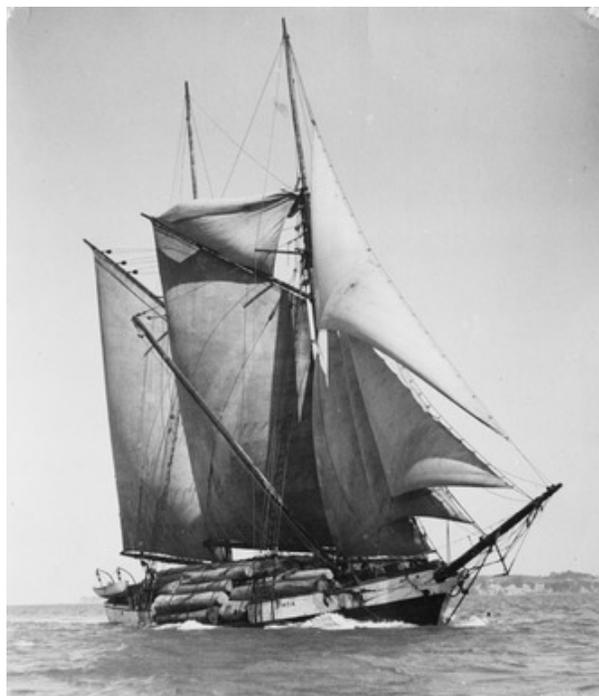
Figure 7. A New Zealand-type scow, *Moa* underway (Auckland Museum).

Scow schooners were especially useful to the New Zealand economy for their ability to transport cargo despite the changing tides and narrow estuaries. The flat-bottomed vessels were able to beach when the tide went out and resume duties immediately upon its return, a feat that surely aided in productivity of maritime trade in New Zealand. The first New Zealand scow was built in 1873, and the last around 1935 (The Jane Gifford Society; Johnson 1987). Scow size grew

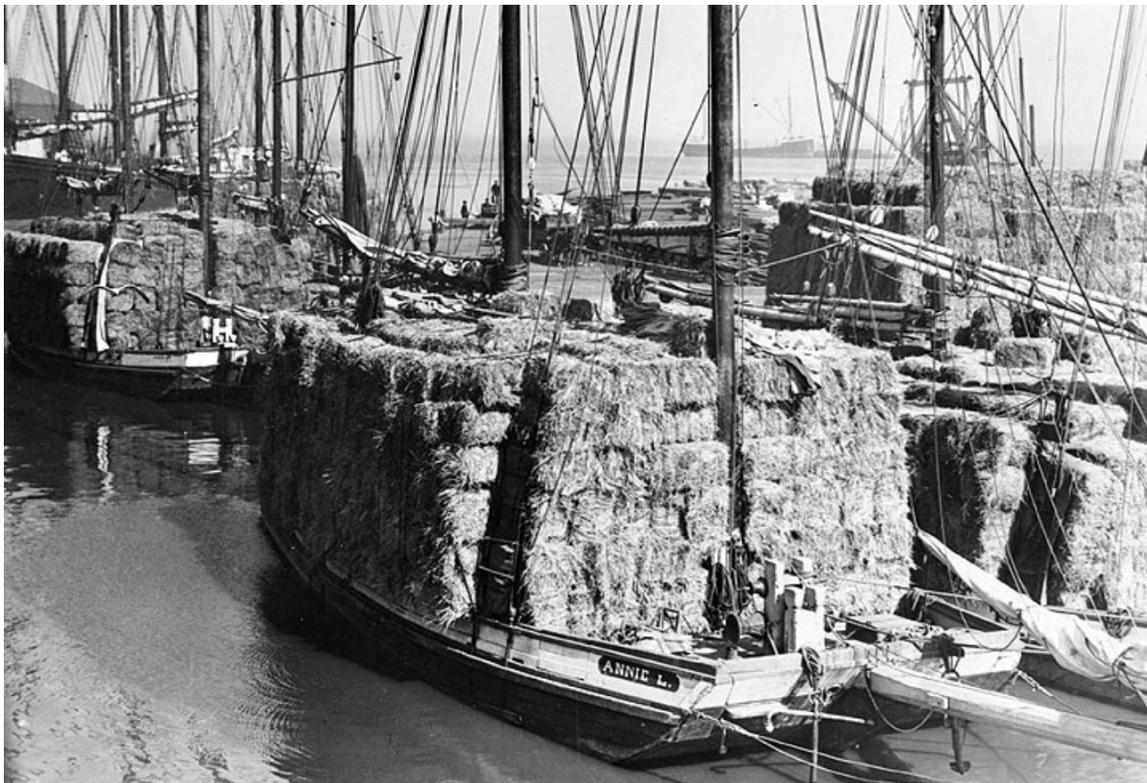
Figure 8. A San Francisco-type scow, *Annie L.* (San Francisco Maritime National Historic Park, National Park Service).

Over 400 scow schooners were reportedly constructed around the San Francisco Bay area (San Francisco Maritime National Historical Park). While similar to the scows of the Great Lakes and New Zealand, San Francisco scows were adapted to local conditions and sometimes referred to as ‘Square-Toed Packets’ (Olmstead 1988: 15). Though they spent a large portion of their time hauling hay, coal, oyster shell, and other cargoes, San Francisco scow owners traditionally sailed their scows to Paradise Cove for family picnics in the spring (San Francisco Maritime National Historical Park). Scows were sometimes rented out in the evening for “dancing and drinking” on the bay; these excursions were known as “drowning parties” (San Francisco Maritime National Historical Park). Unlike the cost-driven needs of Great Lakes scows, San Francisco scow operators made wages that were sometimes higher than offshore crews, due to the specialized jobs they were able to take on (San Francisco Maritime National Historical Park).

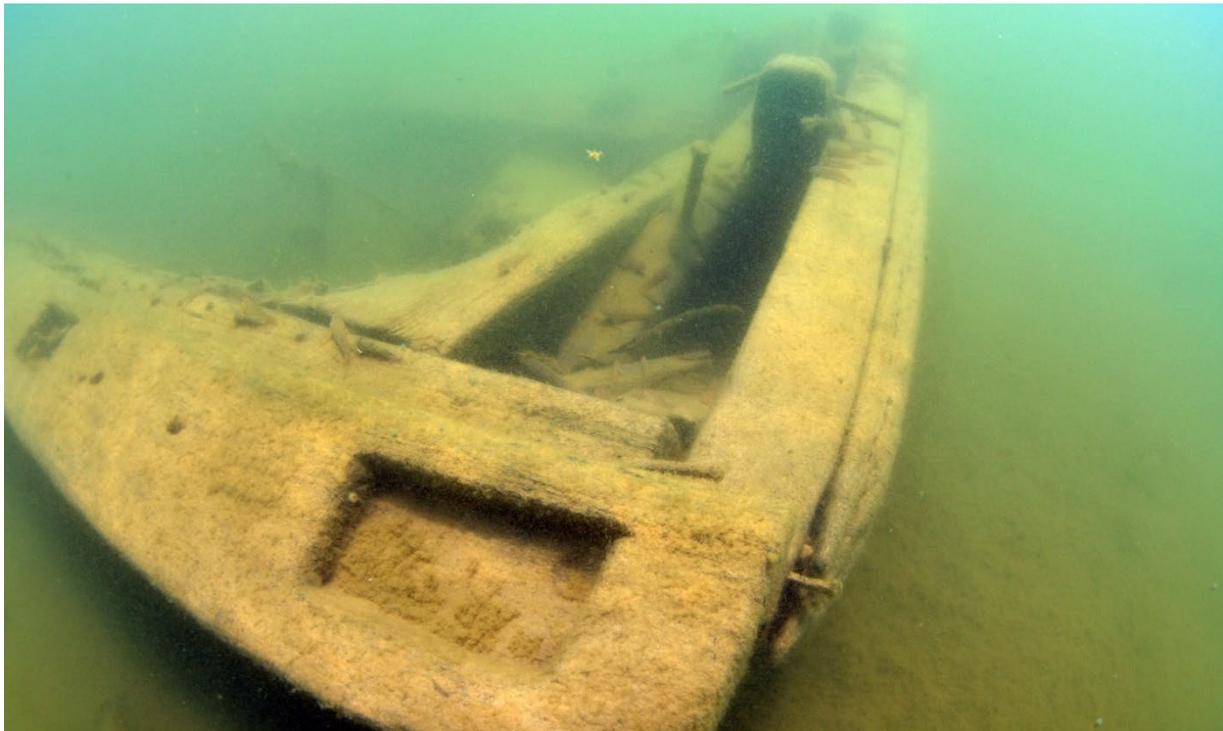
Figure 9. The port side bow of *Alaska* (Wisconsin Historical Society).

The *Alaska* has a boxy, spoon-shaped bow with athwartship planking. To the outside of the bow frames, the vessel's bow ramp appears flat and athwartship planked. King post hull construction was noted. The king posts measured 0.4 feet sided and 0.4 feet molded. Structural members of the vessel's floor, possibly the vessel's chine stringers, located outbound of the stringers that would have rested alongside the chine, measure 0.6 feet wide by 0.8 feet thick on the port side and 0.8 feet square on the starboard side. The difference in measurements could likely be the results of the vessel's extensive repairs. Several pieces of athwartship bottom planking were observed beneath the stringers (Kiefer et. al 2015). The centerboard trunk was badly damaged; it is unclear if it was deployed at the time of sinking.

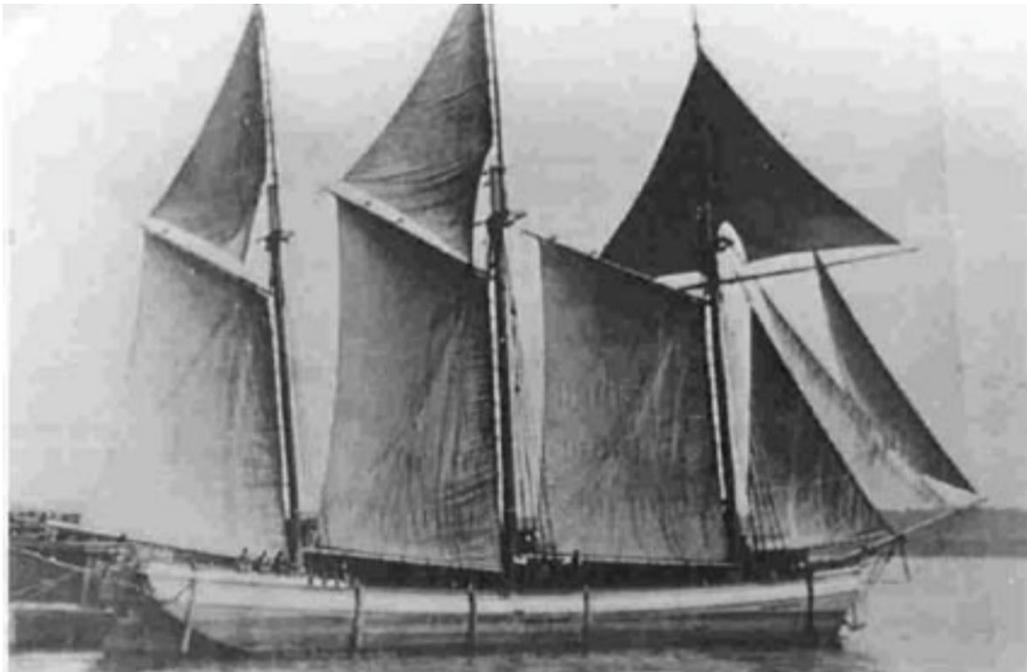
Figure 11. Historic image of *Dan Hayes* under sail (C. Patrick Labadie Collection).

The *Dan Hayes* had a bent bow, with the planking forming a 'V' shape (Rodgers and Corbin 2003: 8). The *Dan Hayes* has a cross-planked bottom, with planking that is 2 in. thick, and with longitudinal ceiling planking, of 1.5 in. in thickness (Rodgers and Corbin 2003: 10-13). The sides of the *Dan Hayes* are fastened at a 90-degree chine, allowed by the presence of a chine log. The chine log accepts the king posts, spaced at 2 ft. intervals, as well as the cross keelsons (Rodgers and Corbin 2003: 12).

Cross, or athwartships, keelsons are mortised into the keel. The cross keelsons are fastened with iron trenails or drift pins driven through the bottom of the ship, suggesting that the *Dan Hayes* was built in sections before being inverted and attached together (Rodgers and Corbin 2003: 9). The site did not have a centerboard trunk or chainplates, leading archaeologists to wonder if the *Dan Hayes* was rigged with masts and sails before being repurposed, or if it ever sailed at all (Rodgers and Corbin 2003: 10).

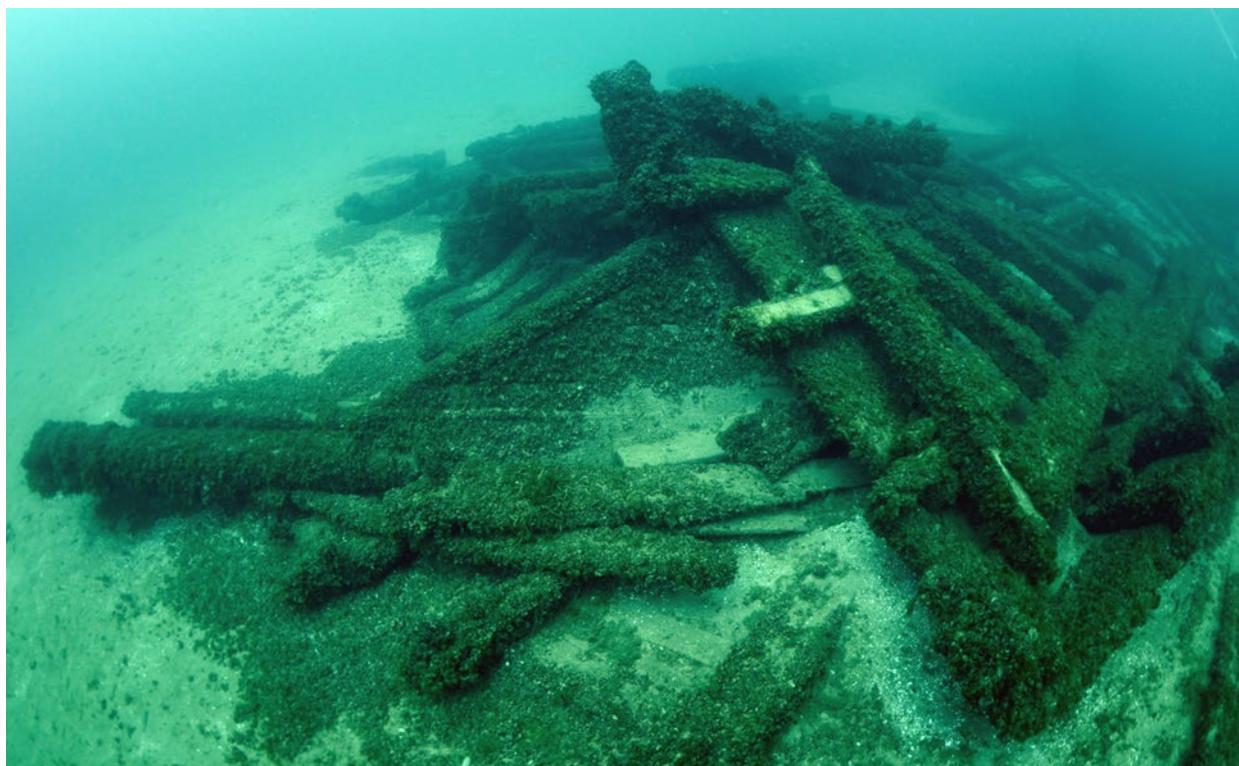
Figure 17. Flattened stern of *I.A. Johnson* showing cross planking and floor stringers/keelsons (Wisconsin Historical Society).

As is typical in scows, the vessel's keel and keelson structure lies within the bilge, allowing the vessel to draw a shallow draft, which facilitated the *I.A. Johnson's* work in shallow, near-shore waters. Due to the accumulation of sand in the vessel's hull, it was not possible to determine if the *I.A. Johnson* was equipped with any sister keelsons, but aft of the centerboard trunk, the keelson appears to have two rider keelsons sitting atop the keelson.

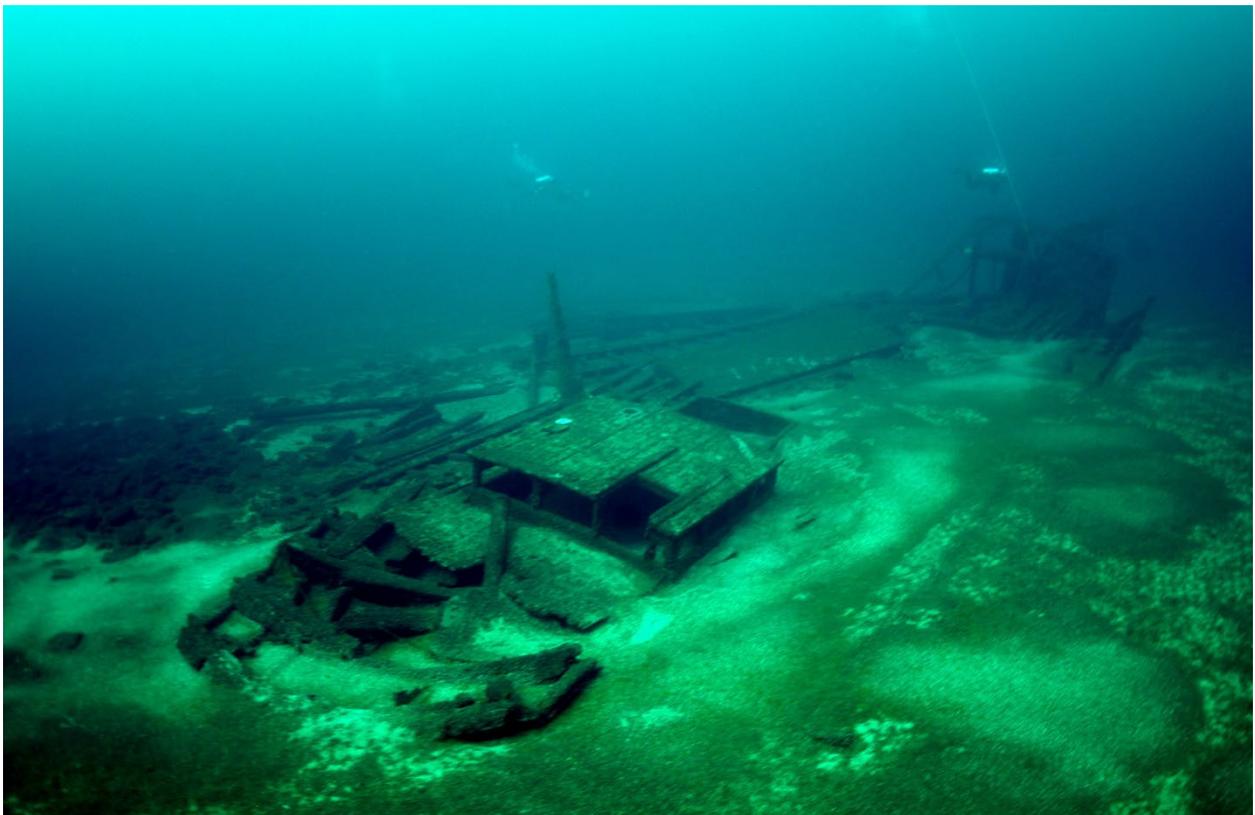
Figure 21. *Ocean Wave*'s stern, looking forward (Wisconsin Historical Society).

Much of the transom and stern ramp's inner planking is missing. Transom outer hull planking measures 4-1/4 in. wide and 1-1/2 in. thick and continues below deck level, onto the cross-planked stern ramp. Both the vessel's port and starboard sides have fallen outward from the hull. The exposed portion of the starboard side is longitudinally-planked with three visible planks (Meverden and Thomsen 2006).

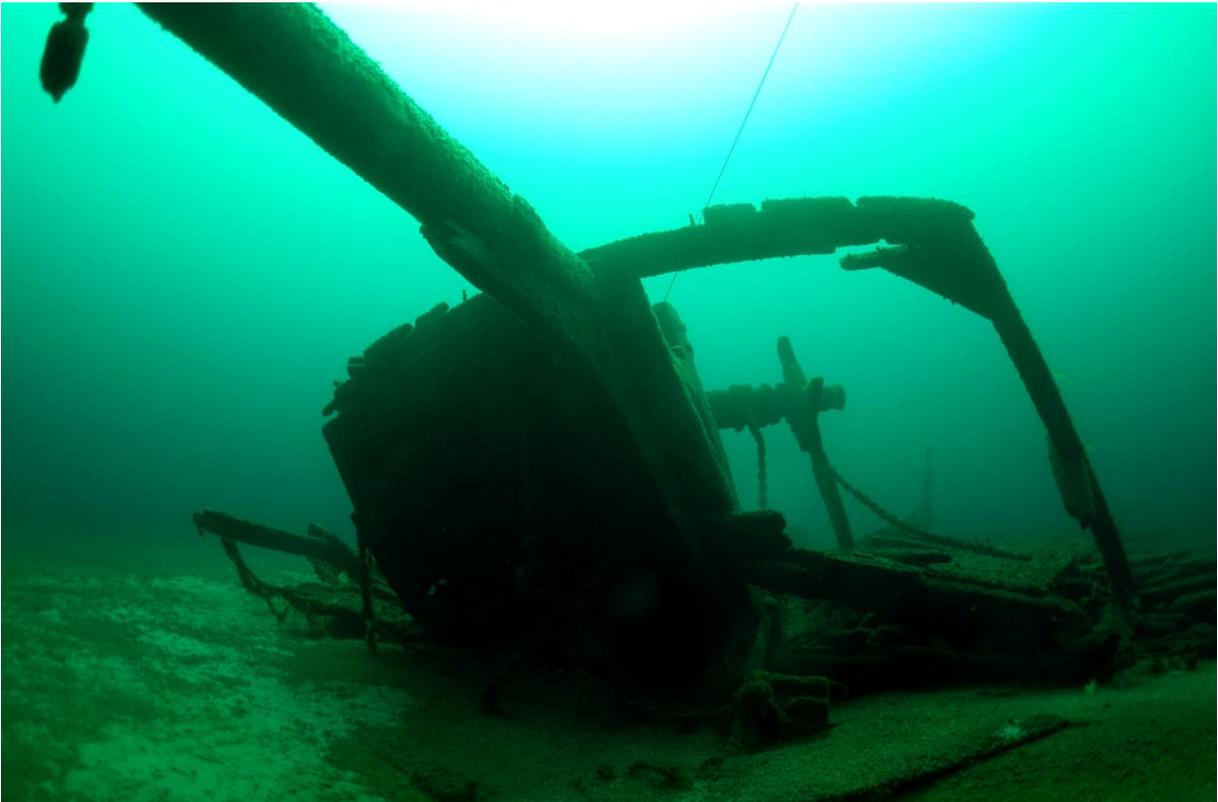
Figure 22. Cross-planked bow of *Ocean Wave* (Wisconsin Historical Society).

Ocean Wave's bow is cross-planked. There is no evidence of a hard chine-type edge between the bow and hull bottom. The bow curves towards the vessel's bottom with no visible transition.

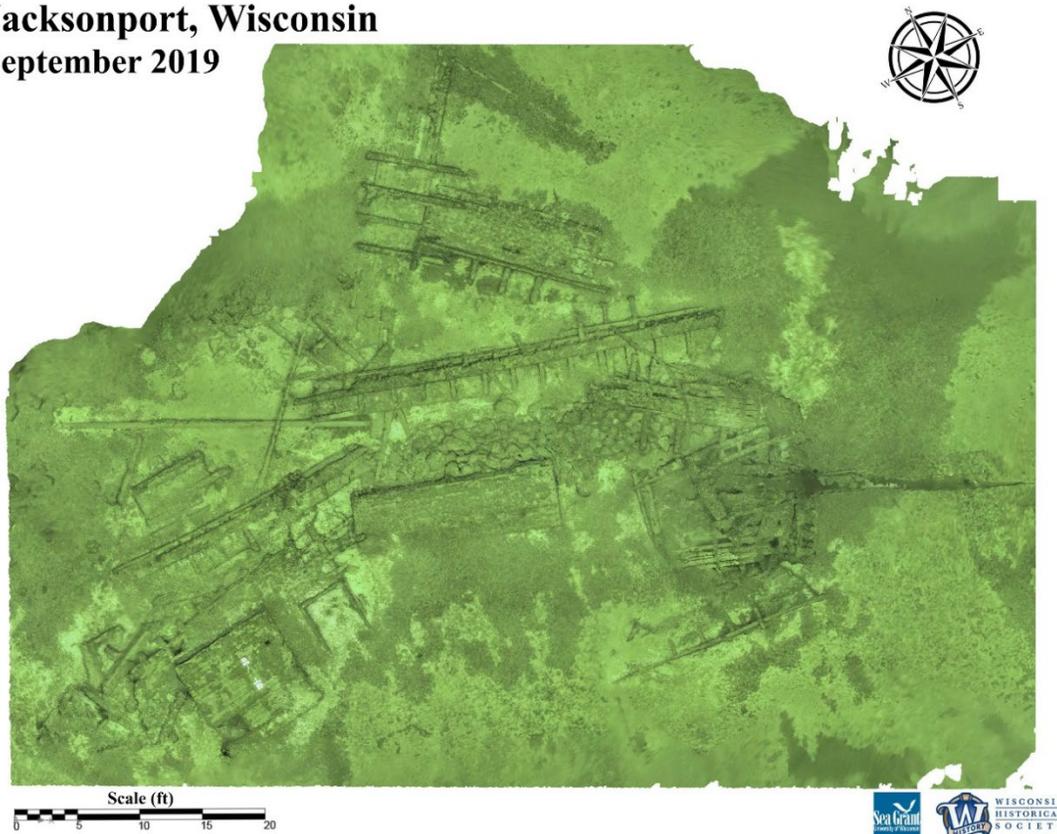
Figure 23. Orthomosaic of the *Ocean Wave* site (Tori Galloway).

Despite an expertise in woodworking skills, the shipwrights allowed one error in their construction that may have resulted in the *Ocean Wave*'s quick descent to the bottom. Scows, with their flat bows, are vulnerable to frontal impacts. Unlike conventional vessels, with a fine entry that minimizes frontal impact, scows take the full force of impact straight on, resulting in greater damage. The *Ocean Wave* had one additional problem with her bow design: her outer hull planking ran over four frames before abutting the stem. The problem occurred where the outer hull planks met the stem, where there was no rabbet to accept the plank's end. The knighthead provided a strong backing for the bow planking, but it ended below the waterline.

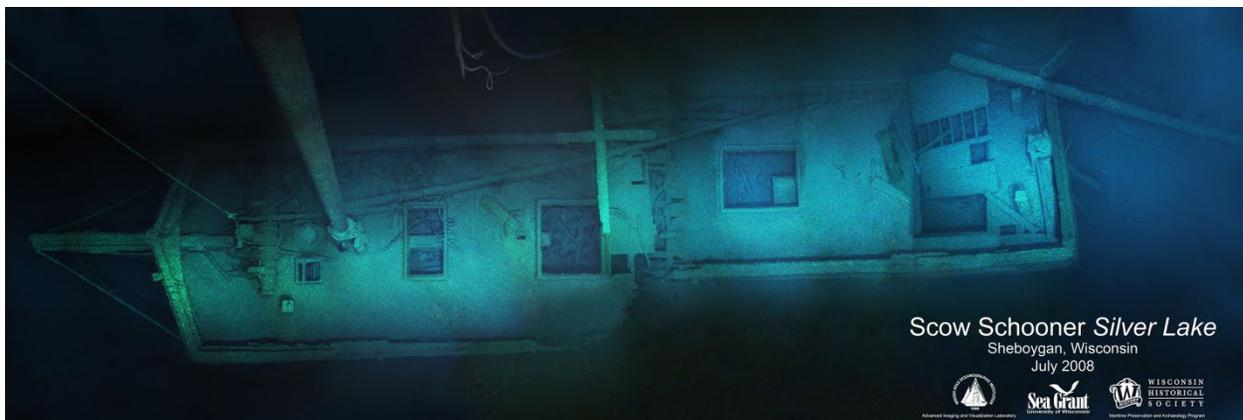
Figure 27. Photo mosaic of *Silver Lake* site (Woods Hole Oceanographic Institution).

The hull’s sides are constructed of longitudinal planks that are 0.65 feet high by 0.45 feet thick. The planks are edge-bolted together and into the chine log, measuring is 0.5 feet wide by 0.9 feet tall. The joint between side hull planks is caulked. Side planks are fastened to the top of the chine log flush with the log’s outside edge so that the chine log forms the turn of the bilge. A sister chine log, 0.6 wide by 0.65 feet tall, is fastened to the inside of the chine log. The sister log serves as both a reinforcement and as a chock, upon which the ends of the athwartship ceiling planks are supported and fastened. The ceiling planks are 0.15 feet tall by 0.75 feet wide and abut the inside edge of the chine log with the tops of the ceiling planks flush with the top of the chine log (Thomsen and Meverden 2011b).

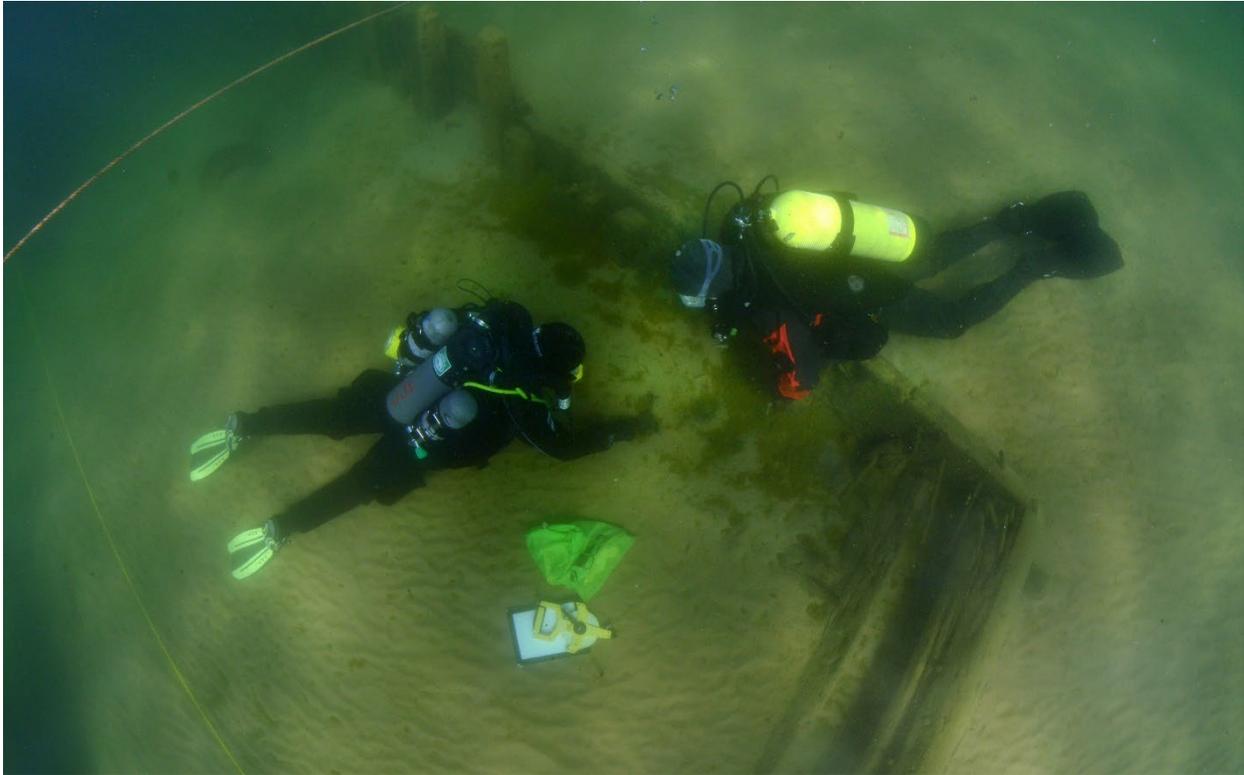
Figure 29. Two archaeologists investigate the double frames of *Success* near the vessel's bow (Wisconsin Historical Society).

The lower sections of the port side of the vessel remain standing upright still connected to the bottom of the hull with a 90-degree chine. The sides of the vessel are comprised of longitudinal outer hull planking measuring 0.3 feet thick and 1.0 foot wide. The outer hull planks are edge fastened, although a few planks are joined by plain scarfs (Zant and Thomsen 2015).

Unlike traditional scow schooners of the Great Lakes, *Success* was not built with a series of king posts spaced throughout the length of the ship but was instead constructed in a manner closely resembling regular schooner construction. *Success* had double frames with futtocks measuring 0.55 feet and 0.45 feet wide, and 0.45 feet thick. Although many of the futtocks of each frame have been broken or damaged, evidence of their fasteners and their placement is visible along the interior of the hull planking, where the planking is grooved to fit the timber. The frames are spaced irregularly. A 25-foot-long section of the ceiling planking on the port side lies 57.0 feet from the sternpost; it measures 0.4 feet wide, 0.1 thicker than the outer hull planking, a method of construction common throughout the Great Lakes region. The hull structure is through-bolted and peened from the interior of the ceiling planking (Zant and Thomsen 2015).

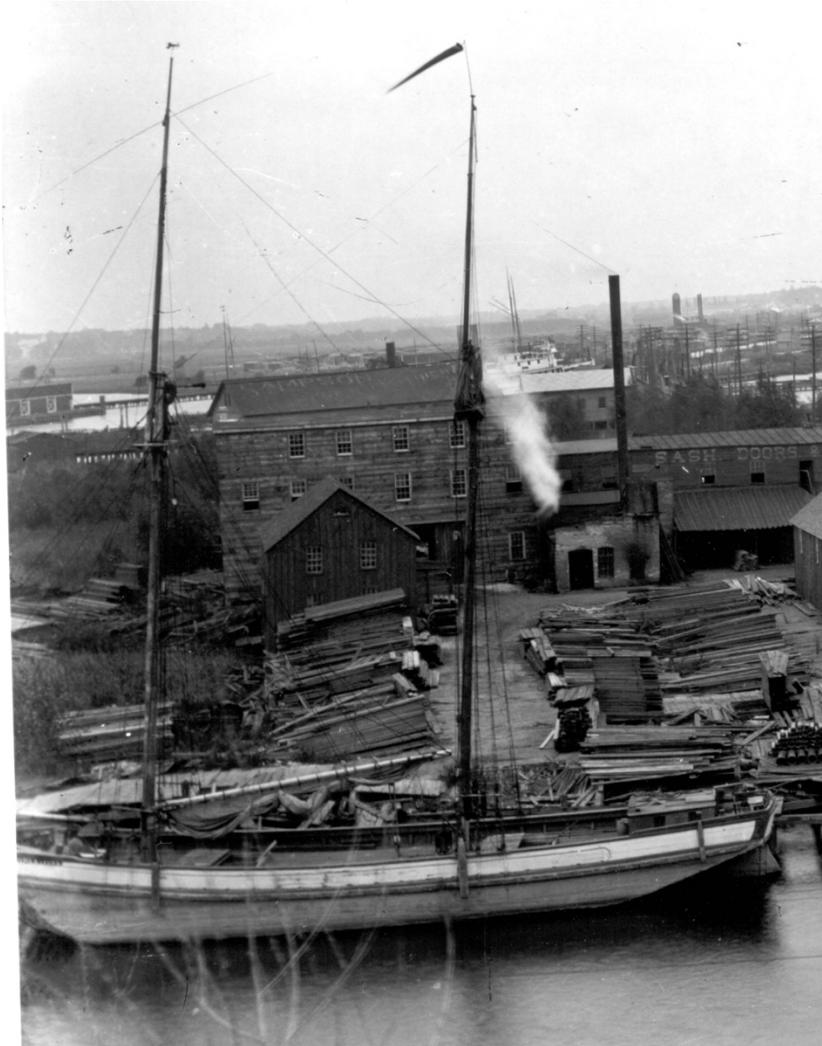
Figure 31. Historic image of *Tennie and Laura* at a dock (Milwaukee Public Library).

The scow schooner *Tennie and Laura* was built in 1876 at Manitowoc, Wisconsin, by Gunder Jorgensen. *Tennie and Laura* was described as having one deck, two masts, and measured 73 feet in length, 19 feet in beam, and 5.6 feet in depth. Her registered tonnage was 53.9 net and 56.69 gross. She was owned in equal shares by Otto A. Bjorkgnist and Ole Osmondson of Port Washington, with Captain Osmondson as Master (Meverden and Thomsen 2007).

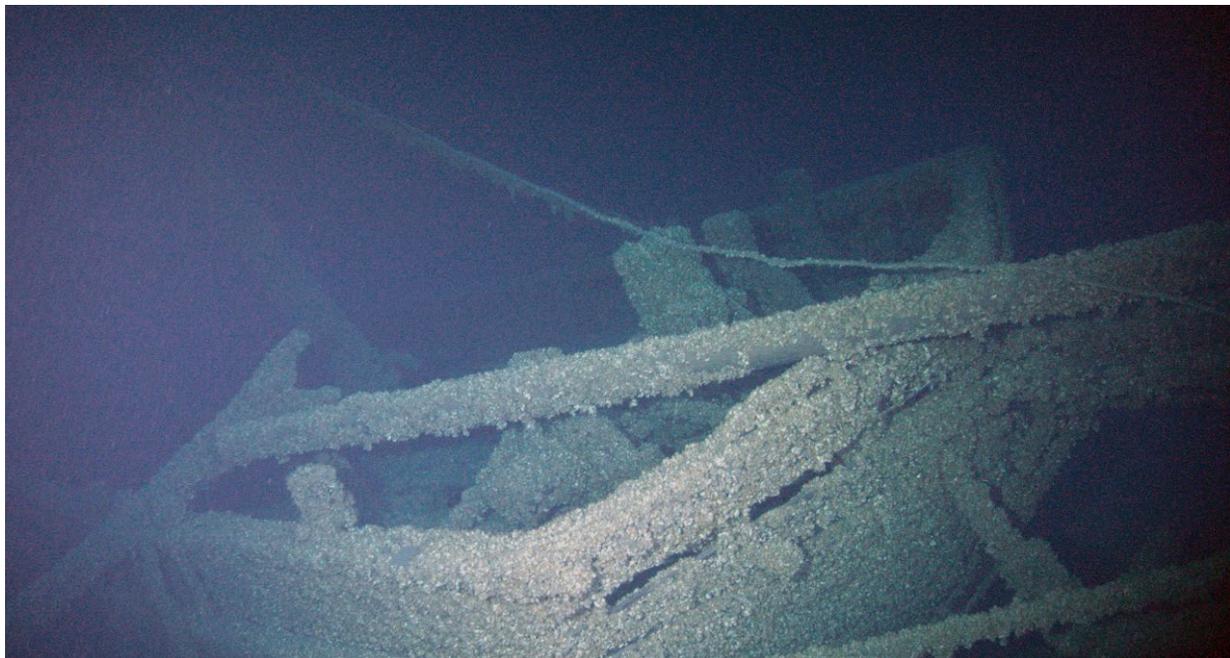
Figure 32. ROV image of *Tennie and Laura*'s V-bow (Marine Imaging Technologies).

The vessel's bow ramp is cross-planked, joined to the longitudinal side-planking by framing timbers. The bow curves upward sharply from the bottom and appears to be constructed of two separate panels. These panels are joined together to create a v-shaped bow that extends 1.6 feet forward of the framing timbers, where it connects at the stempost and is reinforced by a breasthook (Meverden and Thomsen 2007).

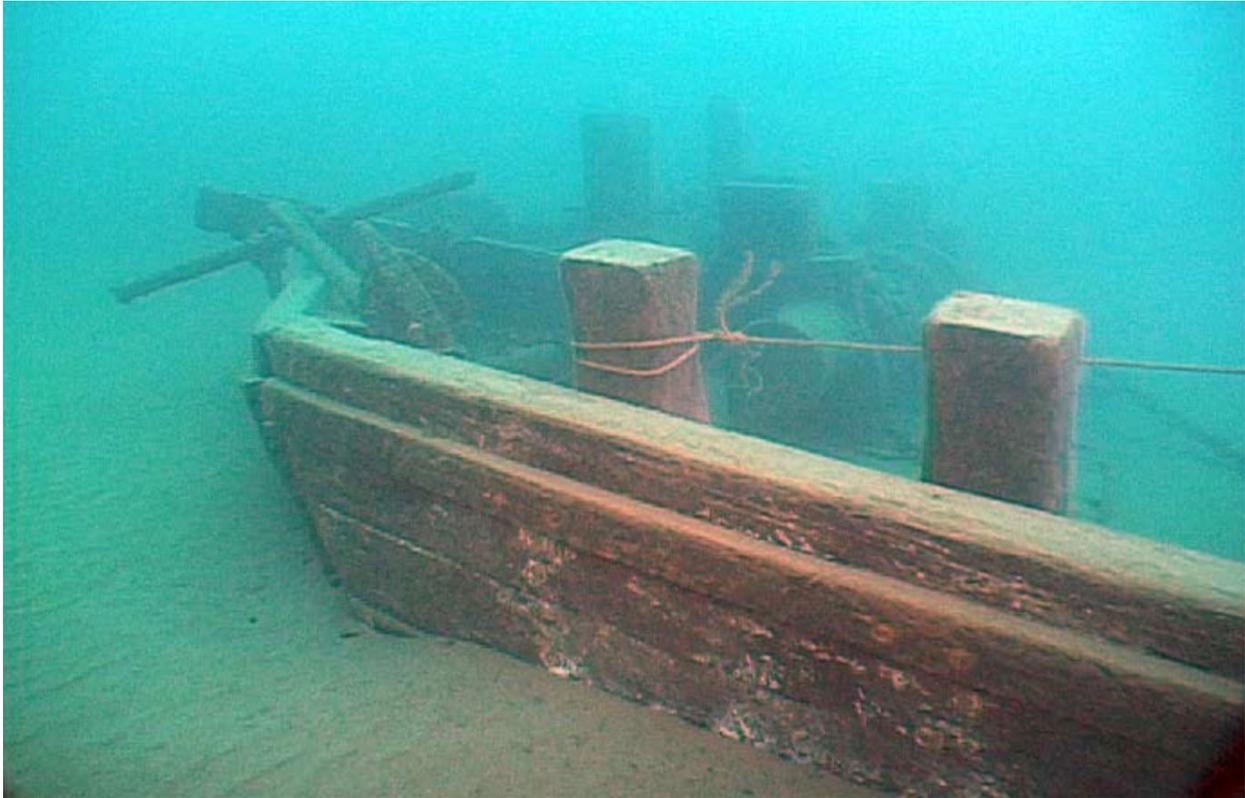
Figure 33. Bow and port side of *May Flower* (Ken Merryman).

The *May Flower's* outer hull planks are 0.65 feet wide by 0.3 feet thick and are edge bolted together with iron bolts. Although buried in the sand bottom and difficult to distinguish, it appears that the hulls sides and bottom are joined with a chine log that is mortised to accept the king posts. The bulwark stanchions are fastened to the forward side of the king posts and are 0.55 feet square with a space of 2.5 feet between stanchions (Meverden and Thomsen 2011).

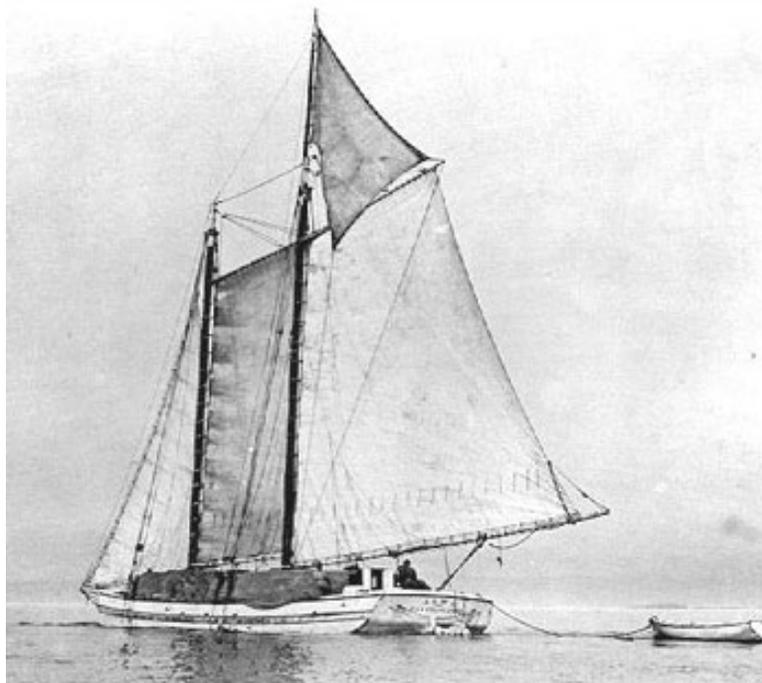
Figure 43. *Alma* on San Francisco Bay, circa 1900 (San Francisco Maritime National Historic Park, National Park Service).

Alma, constructed by Fred Siemer in 1891, is the only known remaining scow schooner from San Francisco Bay (Historic American Engineering Record 1968c). *Alma*'s construction was reported to be, "not unique, but unusual" (San Francisco Maritime National Historical Park). This, of course, is relative to the patterns of scow building in San Francisco Bay, as *Alma*'s design differs noticeably from Great Lakes and New Zealand scows. Like most scows, *Alma* was equipped with a centerboard (Historic American Engineering Record 1968d). *Alma*'s bottom planking ran athwartship (San Francisco Maritime National Historical Park). The side planking ran longitudinally, and the bow and stern were both flat (Historic American Engineering Record 1968: b; c; e). While flat bows were also seen on the Great Lakes, a number of New Zealand scows were built with v-shaped bows (Hawkins 1965). This design was likely because San Francisco scows were used mainly for sailing the rivers and San Francisco Bay, rarely travelling far from shore. New Zealand scows travelled offshore more frequently, as did Great Lakes scows, which could account for the variation in bow design. Based off of *Alma*'s construction and off of historical images, it appears that San Francisco scows did not utilize a breast hook. Because San Francisco scows were completely flat-bowed, there appears to be no need for a breasthook.

Alma's rigging allowed for her steering wheel to be raised in order to see over the hay stacks she carried early in her career (Historic American Engineering Record 1968a). Scows like *Alma*, nicknamed "hay scows", would "reef up" their sails in order to raise them above the stacks of hay bales on deck (San Francisco Maritime National Historical Park). In 1918, *Alma*'s masts

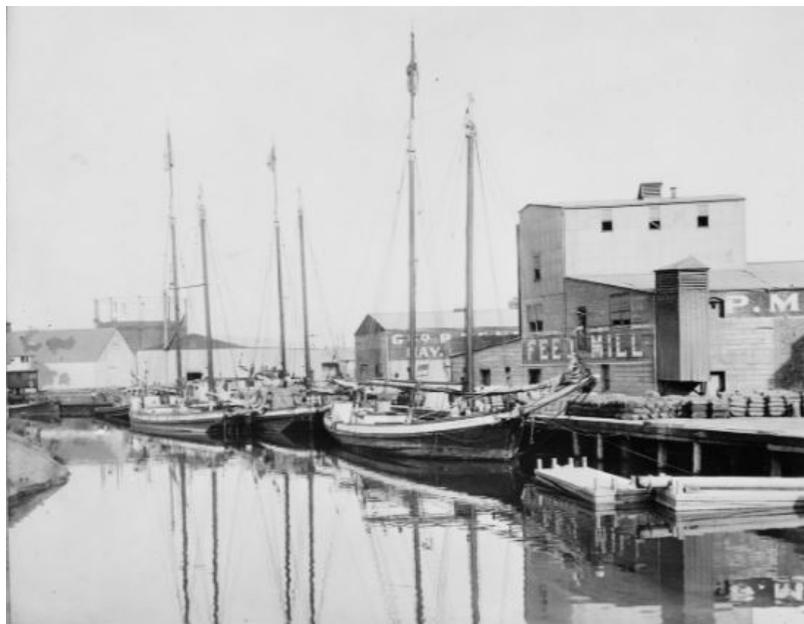
Figure 44. *Crockett* (and other scows) at a feed mill (San Francisco Maritime National Historic Park, National Park Service).

While most features of the *Crockett's* construction were common for the Bay Area, deck beams on the *Crockett* were bent to the crown of the deck rather than cut at the edges (Olmsted 1988: 68). The heavy timber atop the stem piece, called the 'anchor stock', was double, and joined the stem and keel firmly together (Olmsted 1988: 68). The floors ran through the keel, except for the section where the centerboard and centerboard case were fitted. *Crockett* was longitudinally planked, as most San Francisco scows were, and had a flat bow and stern (Olmsted 1988: 71). *Crockett* also had a four-berth cabin below deck, which were usual accommodations of a scow of similar size on the West Coast. *Crockett* exhibited many other characteristics of San Francisco scows, such as 3-inch planking that was said to have been "almost universal except in log-built (or cross-planked) scows" (Olmsted 1988: 71). Because of details revealed through the archaeological record, we are able to understand that this 'universal' characteristic of San Francisco scow schooners was not the case for scow schooners of the Great Lakes, which were known to be constructed with non-uniform planking.

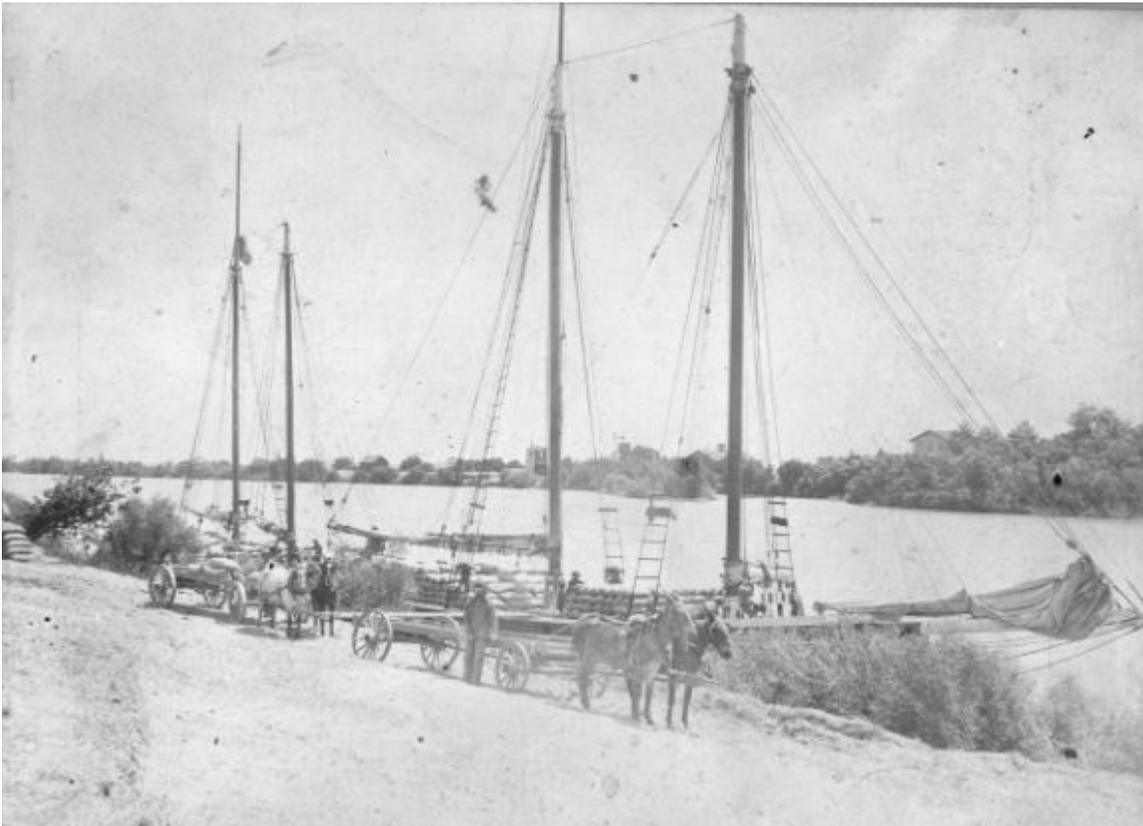
Figure 45. *St. Thomas* at Steamboat Slough (San Francisco Maritime National Historic Park, National Park Service).

Records state that while they were built nearly fifty years apart, the hull form and construction techniques used to build the *St. Thomas* are almost identical to those of the *Crockett* (Olmsted 1988: 70). The main difference between the *Crockett* and *St. Thomas* is the size of the scantlings, attributed to the ability to purchase higher quality materials for a lower price by the time the *St. Thomas* was built (Olmsted 1988: 70). This resulted in “more closely spaced frames- and all-around massive feel to the vessel’s frame” (Olmsted 1988: 70). While there is little evidence, this could have been the case for scows such as *May Flower*, a Great Lakes scow equipped with massive features for no apparent reason.
