Preliminary Report on the SS Wisconsin Archaeological Field Project, Summer 2015

By:
Caitlin Zant and Tamara Thomsen
Wisconsin Historical Society

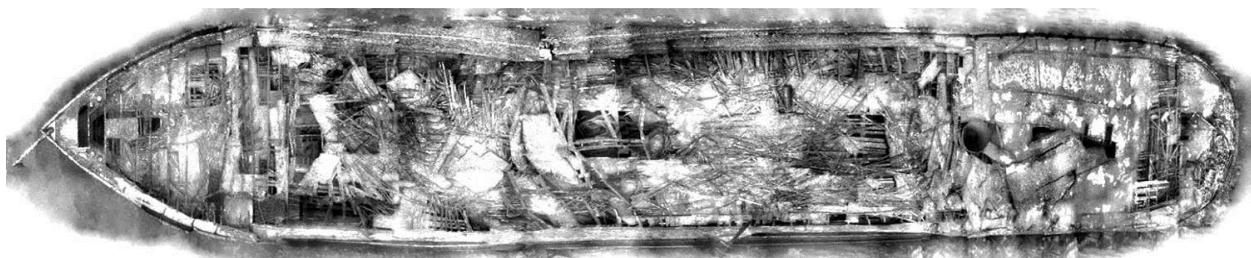
Figure 2: Photomosaic of the Wisconsin using photographs taken in 2005 (Wisconsin Historical Society)

In 2005, archaeologists from Wisconsin Historical Society visited the Wisconsin to collect extensive video data of the site in order to create a photomosaic. The following year, in 2006, archaeologists and volunteers from the Wisconsin Historical Society returned to the site to get extensive measurements and photographs of the site as it rested on the bottom of Lake Michigan.

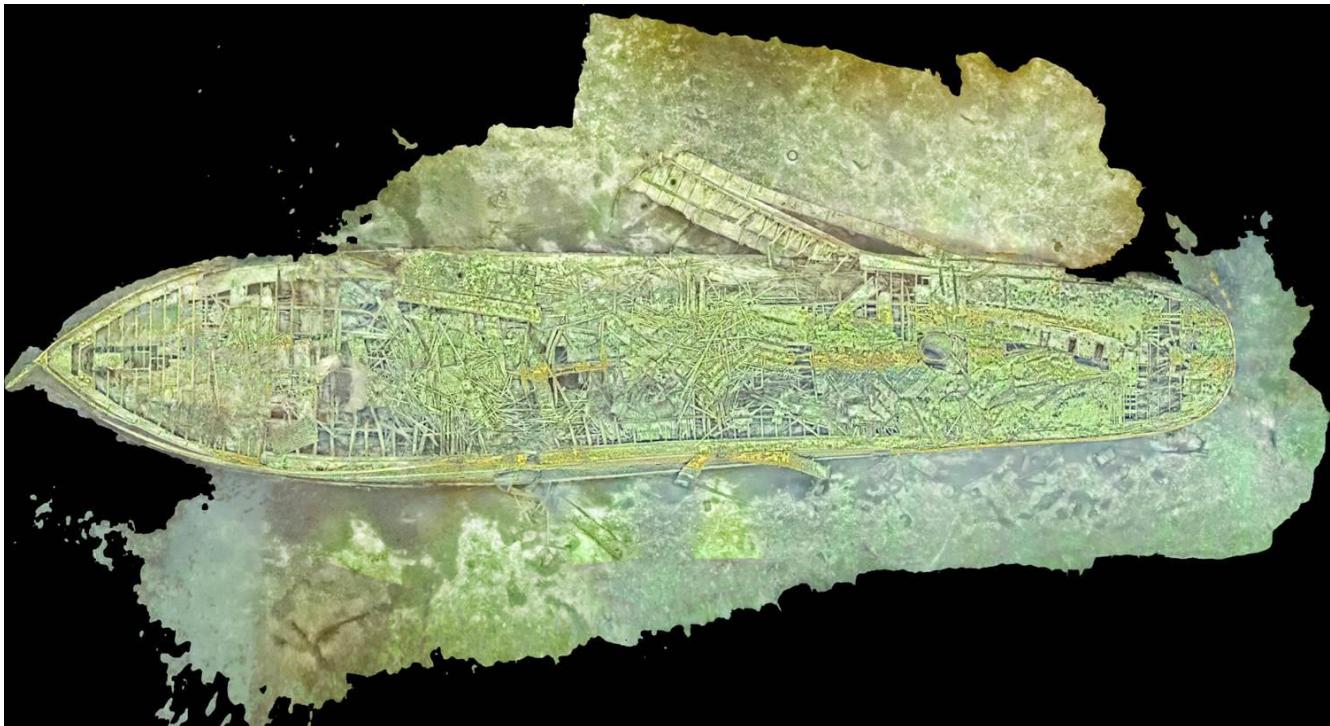
Figure 4: Downward looking 3D model of the *Wisconsin* as it appeared in 2015 (Jordan Mertes, Jason Gulley, Michigan Technological University)

Once video data was collected, the projects focused turned to attempting to quantify site degradation using archived video collected 10 years ago and comparing it to video data collected in 2015. The initial results produced two individual 3D models of the Wisconsin, one from 2005 and one from 2015, from a downward looking view. Because video for the sides of the ship was not collected in 2005, a fully rendered 3D model was not possible.

Beyond just creating two downward looking 3D models of *Wisconsin* in 2005 and 2015, an elevation map was created to show areas of change/twisting/collapse in the hull side by side. The project has also allowed us to create a change map that allows researchers to determine where the shipwreck has changed the most in the last 10 years. By taking the two 3D models, and essentially subtracting one image from another, we were able to determine areas that had large changes, versus areas that had little change. Through this project, we showed that the invasive zebra and quagga mussel colonization has created an acidic microenvironment around our metal shipwrecks that is causing them to degrade at an accelerated rate.
