**Wisconsin Coal Haulers:
Underwater Archaeological Investigations
from the 2012 Field Season**

**State Archaeology and Maritime Preservation Technical
Report Series #13-001**

Keith N. Meverden and Tamara L. Thomsen

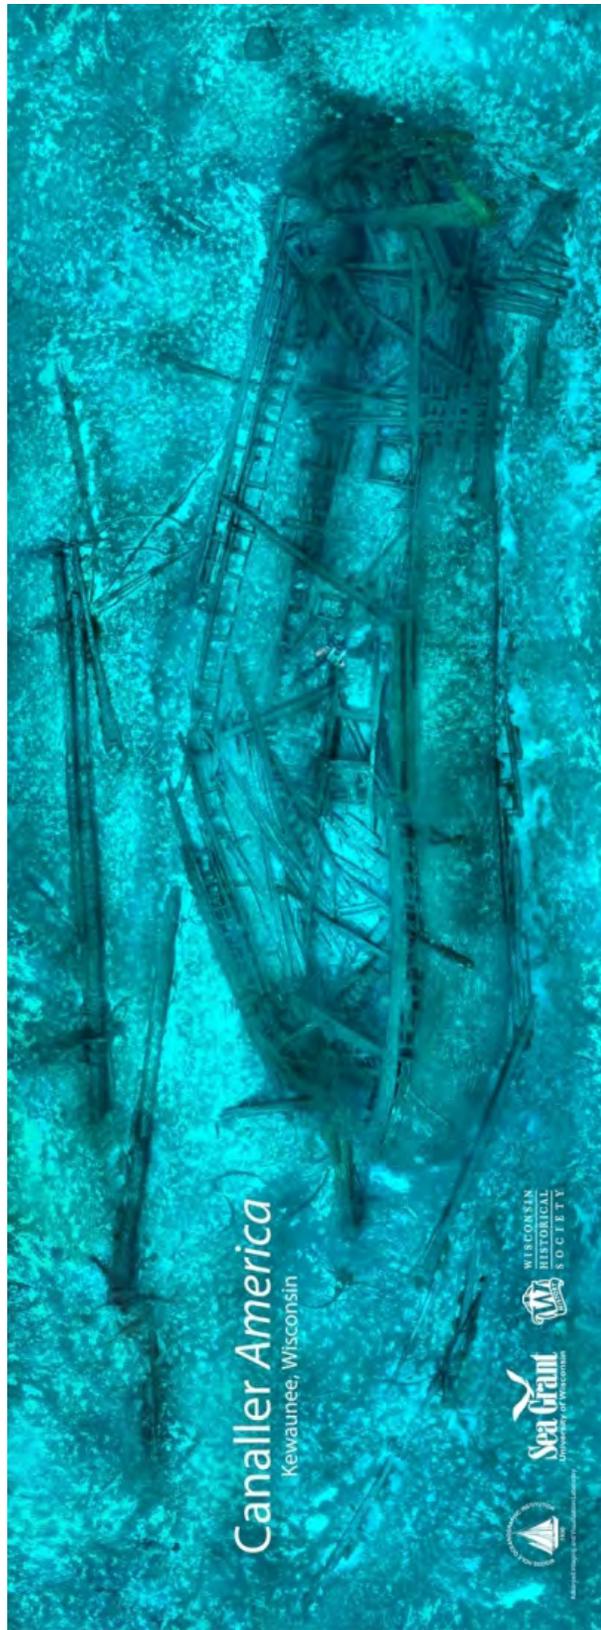
The *America* site lies in 120 feet of water 8 miles south southeast of the Kewaunee River outlet on Lake Michigan (Figure 1). Lying on a heading of 130 degrees, the deck has collapsed and both the port and starboard sides have broken at the turn of the bilge and fallen to starboard. Despite its broken condition, however, nearly all of the vessel's hull structure and standing rigging is extant, but scattered around the site (Figure 2).

Figure 2. Photo mosaic of the *America* site.

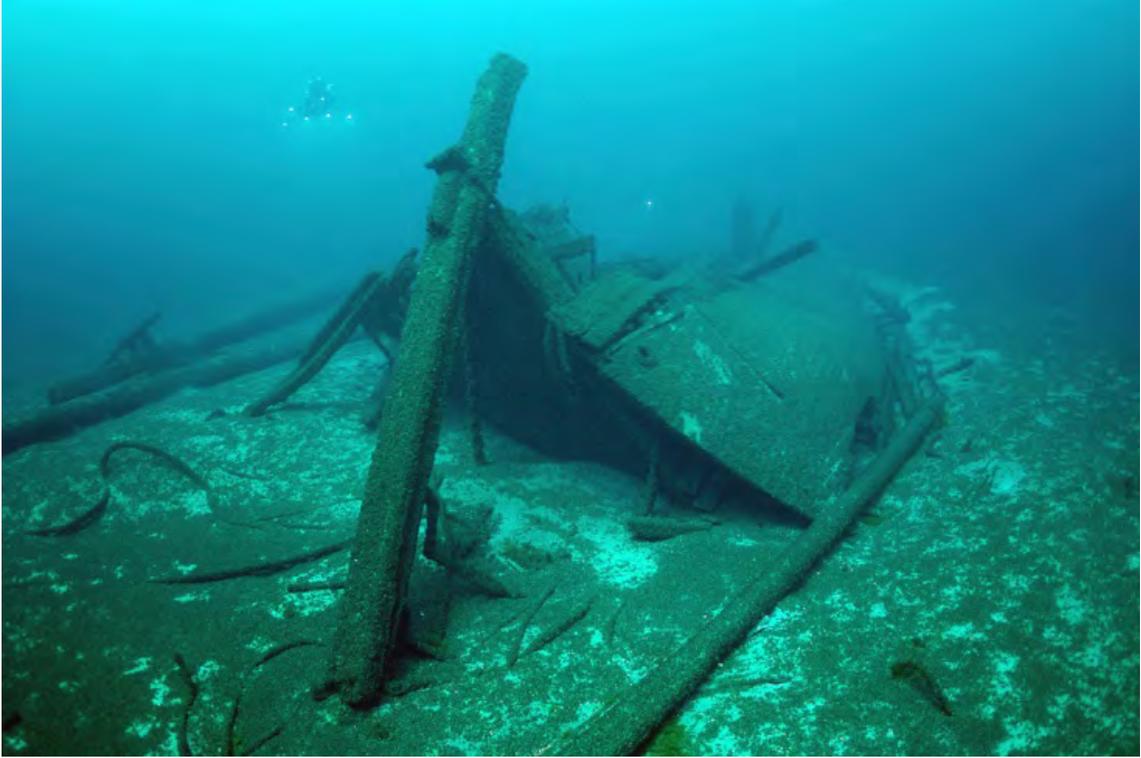
The bowsprit has unstepped from the samson post and pivoted forward at the top of the stem; the head of the bowsprit now rests on the lakebed at an angle to stem (Figure 8). The bowsprit is 29.8 feet in length; its housing is square in section at 1.4 feet sided by 1.2 feet molded. The bowsprit's hounded length is 20.0 feet, and a plank is fastened to the top of the bowsprit that is 2.0 feet wide by 0.3 feet thick. Beneath the plank the bowsprit is round in section with the exception of the upper surface that is planed flat to accept the plank. The tenon on the base of the bowsprit is 0.45 feet wide, 0.55 feet tall, and 1.3 feet in length. The tenon is rounded on its upper edge to allow the bowsprit to be raised vertically while the tenon remains stepped within the samson post.

Figure 8. The *America*'s bowsprit, viewed from forward of the bow, looking aft.

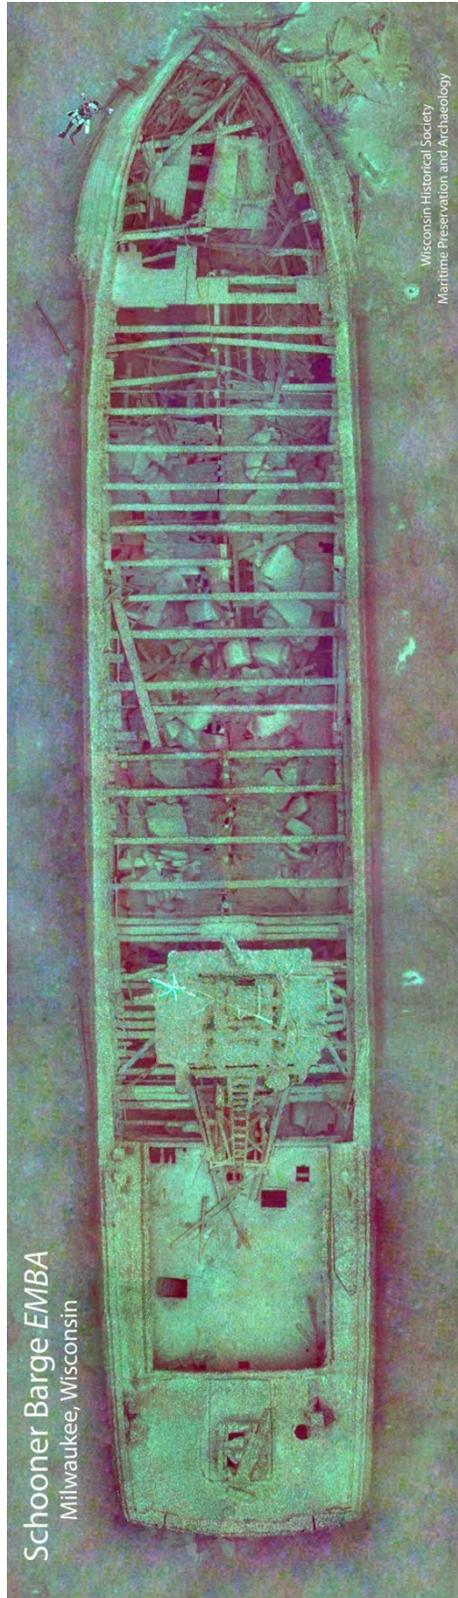
The *EMBA* lies upright and mostly intact in 168 feet of water five miles east of Milwaukee's North Point on a heading of 005 degrees with a five degree port list (Figure 14). The weather deck lies at a water depth of 156 feet, and the top of the unloading tower rises to a water depth of 136 feet. The vessel was stripped and intentionally scuttled in 1932, but the hull and much of her self-unloading gear are extant with the exception of the unloading boom, which was removed prior to scuttling. The hull struck the bottom bow first, which resulted in the only damage to the hull in a broken upper stem and cant frames that caused the windlass deck to collapse and the windlass to fall into the forecastle area (Figure 15).

Figure 15. Photo mosaic of the *EMBA* site. Note diver off port bow.

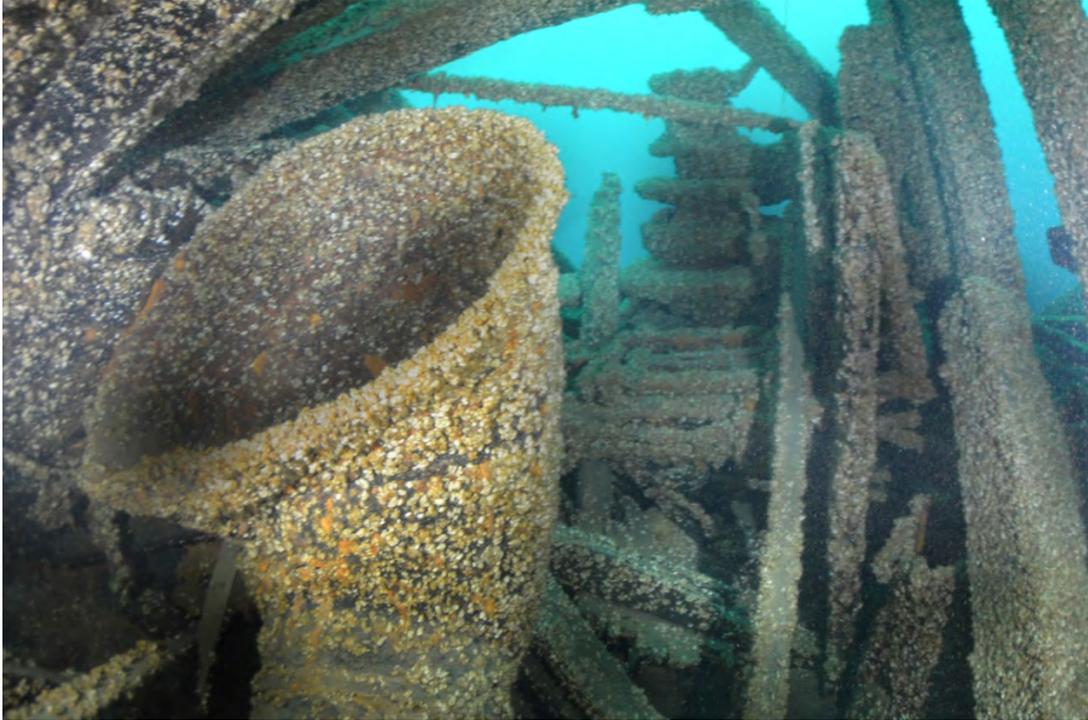
A vertical steam pump rises from the vessel's floor within the forecabin, mounted to starboard of the keelson. A large, steel ventilation funnel lies below deck immediately aft of the collapsed windlass (Figure 18). The hawse pipes lie within the bow wreckage, but the anchors are not extant and were presumably removed prior to scuttling.

Figure 18. Large ventilation funnel lies below deck aft of the windlass, visible in the background.

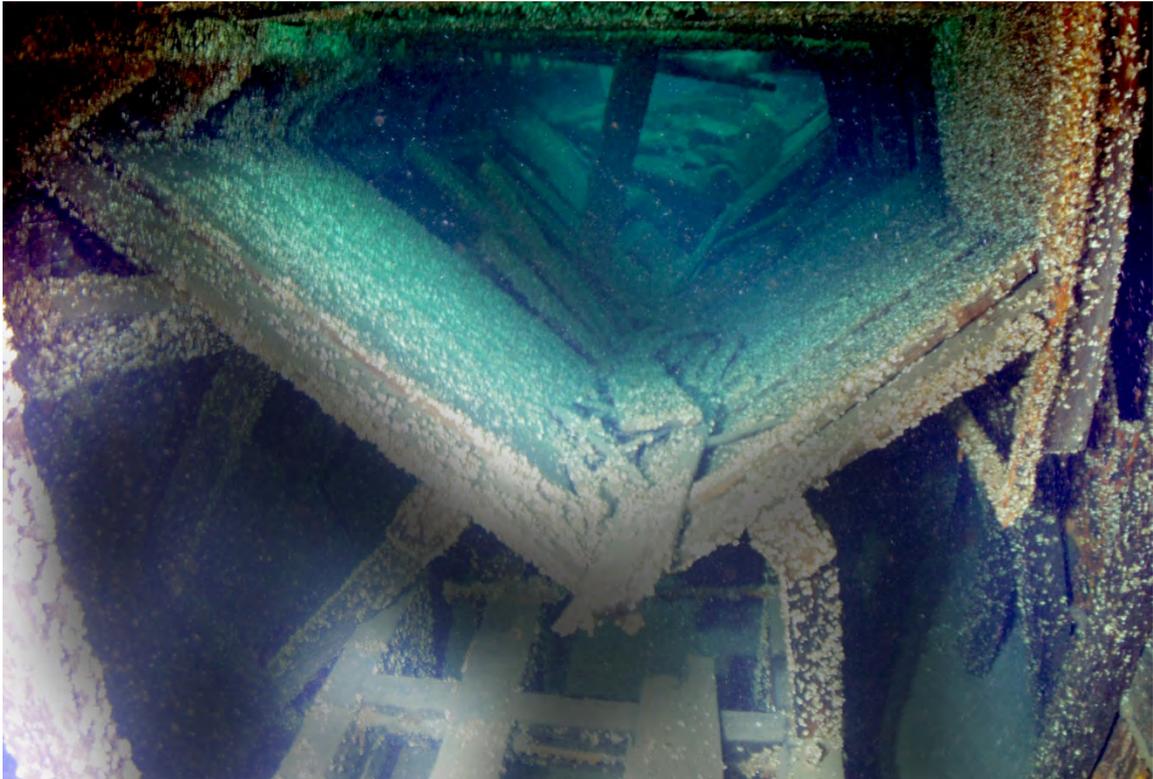
Figure 20. Aft end of port side hopper, looking forward. Frame for conveyor is visible beneath the V-shaped hopper. Deck beams are visible at top of image.

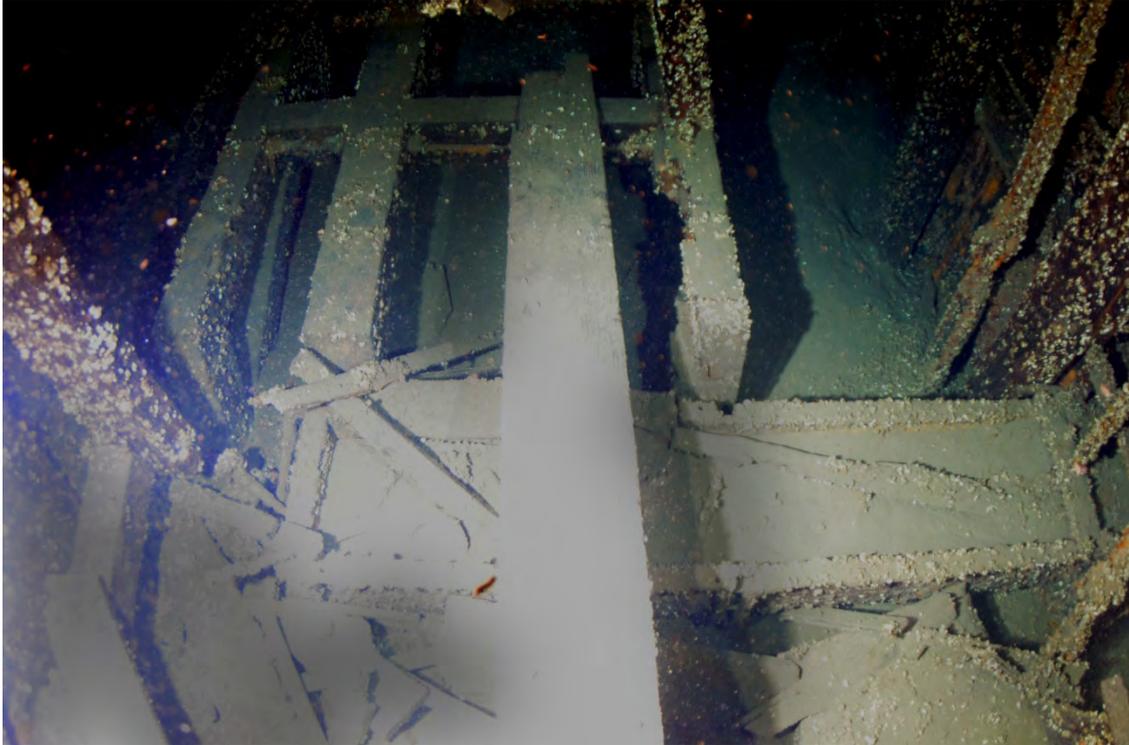
The doors emptied the hoppers onto two longitudinal conveyers that were located directly beneath either hopper. The belts of these conveyers have been removed, but the wooden framing remains extant. The longitudinal conveyers moved the cargo aft to where they emptied onto two lower, athwartship conveyers that moved the cargo to the center of the vessel behind the bucket tower (Figure 22). There, each of the athwartship conveyers emptied into the tower's buckets to be carried up onto the deck. The framing for the athwartship conveyers remains in place, but it is uncertain if the conveyor belts themselves are extant, as these conveyers are quite low within the hull and thus deeply buried in the silt that has accumulated within the hull. Any disturbance of this silt quickly eliminates any visibility within the hull.

Figure 22. Intersection of port side longitudinal and athwartship conveyors.

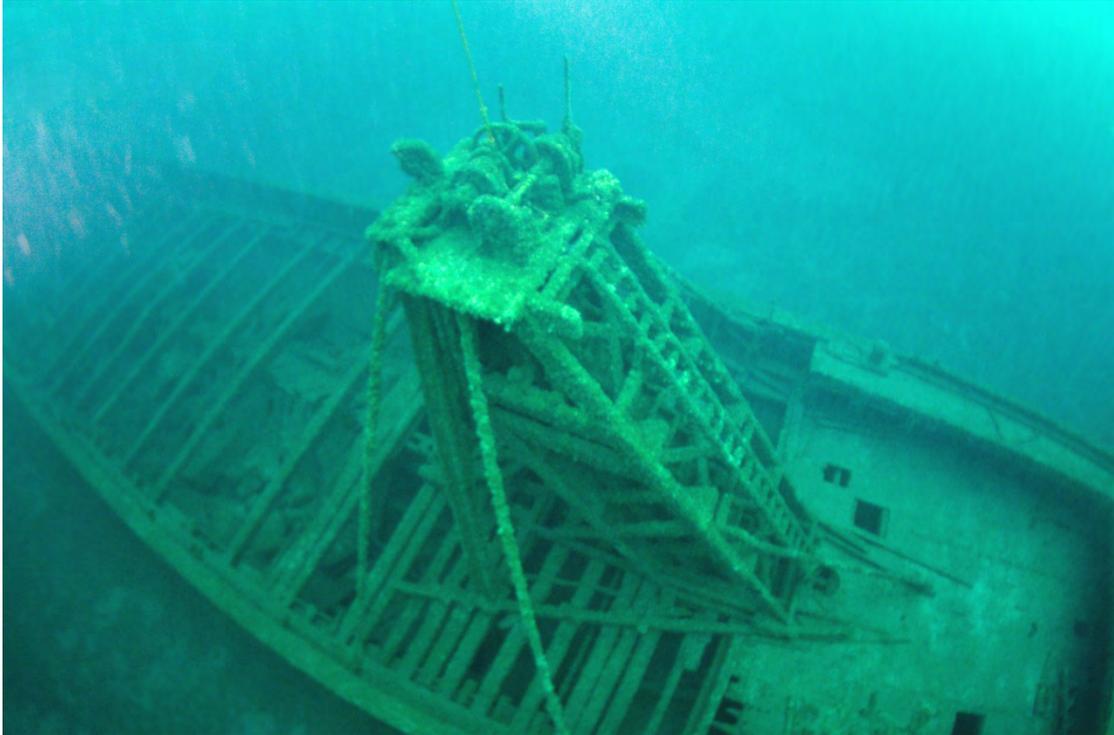
The bucket tower is angled forward as it protrudes from the weather deck and rises 20 feet vertically above the deck (Figure 23). The tower is supported by four legs and four guy wires. The guy wires connect the top of the tower with the vessel's rail on either side. The four support legs are tied to one another via an A-shaped base. This base is constructed of I-beams and connects the unloading tower with the weather deck and provides a wide footprint for resistance to leveraging the deck. The A-shape of the base is wider at the forward end than aft. Each leg of the base is 25.5 feet in length, beginning at 132.8 feet on the baseline and ending at 157.6 feet on the baseline. The base is constructed of I-beams 0.9 feet tall by 0.35 feet wide. The forward leg is fastened to the base 4.4 feet from the forward edge of the I-beam, and the aft leg is fastened 4.0 feet from the aft edge of the I-beam. Athwartship I-beams are fastened between the forward legs, as well as between the aft legs.

Figure 23. View of bucket tower's port and aft sides.

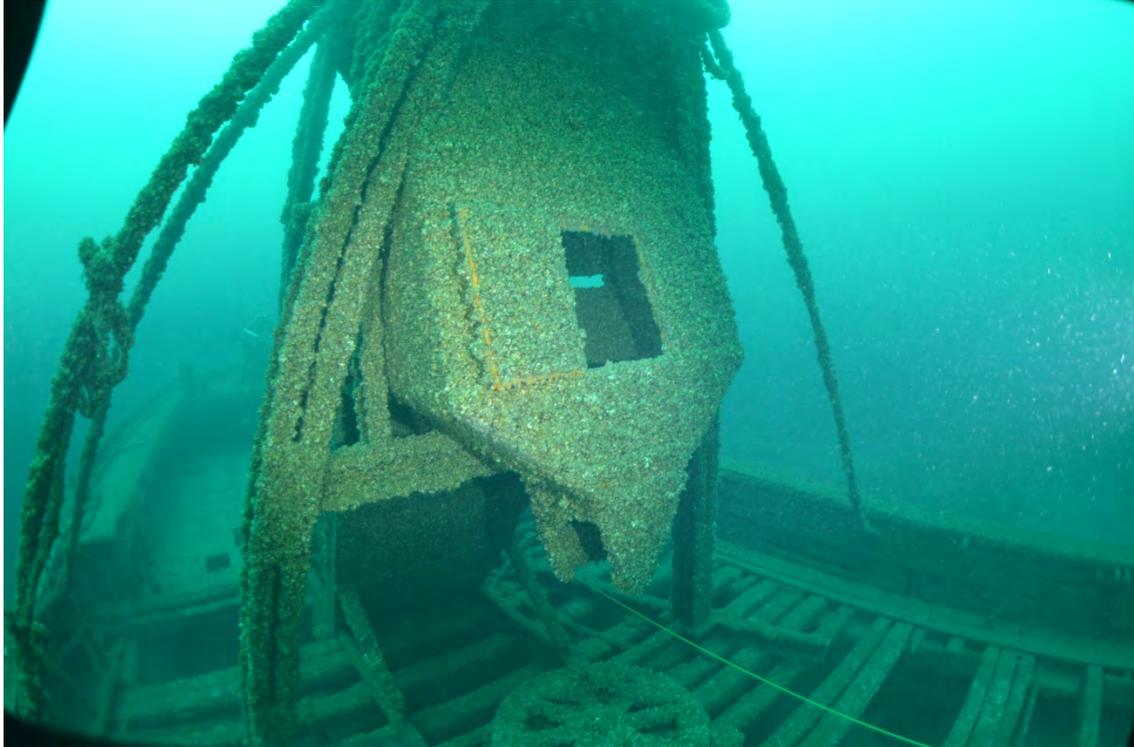
As the buckets came over the top of the conveyor, they dumped cargo into a large iron hopper that is 6.0 feet wide by 2.4 feet long at the top (Figure 24). The bottom of the hopper is formed into a funnel with an opening diameter of 1.4 feet, which deposited the cargo onto the unloading boom.

Figure 24. View of hopper and funnel on forward side of unloading tower.

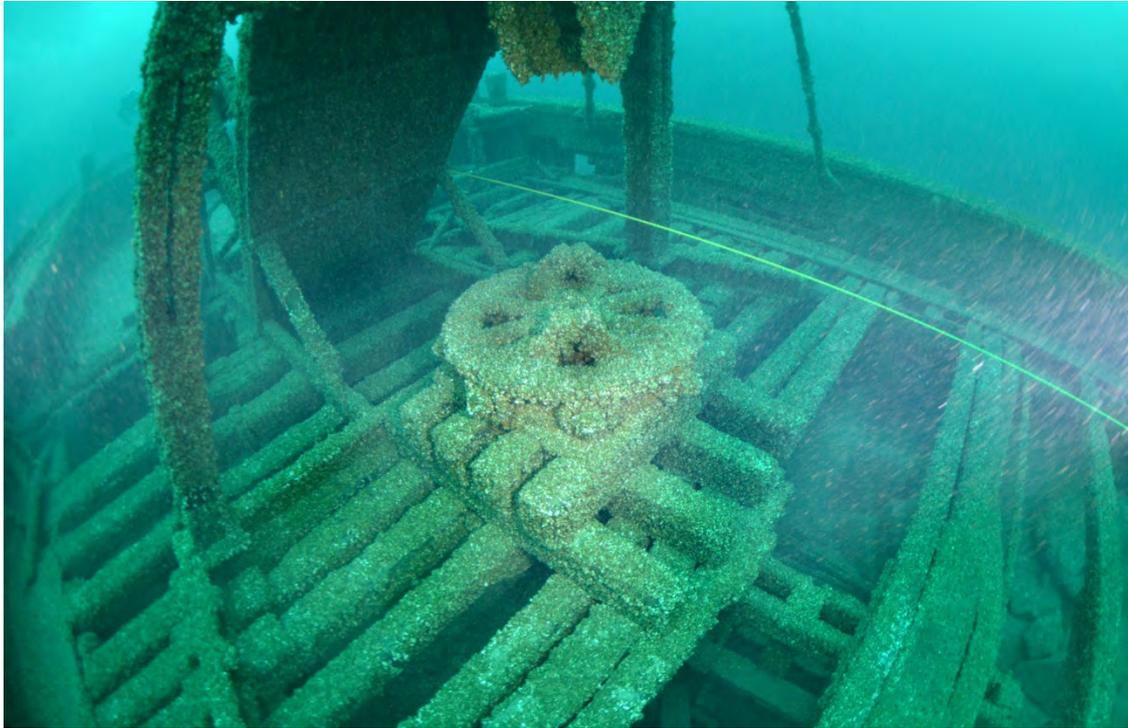
The unloading boom was fastened to the deck beams forward of the unloading tower. Although the boom was removed, its pivoting mount is extant on the deck (Figure 25). The mount allowed the boom to be swung over either rail to unload cargo onto the shoreline. Both the bottom of the funnel and the center of the pivoting base are located at 134.0 feet on the baseline.

Figure 25. The mount for the unloading boom is extant on deck. The bottom of the hopper funnel is visible at top of image.

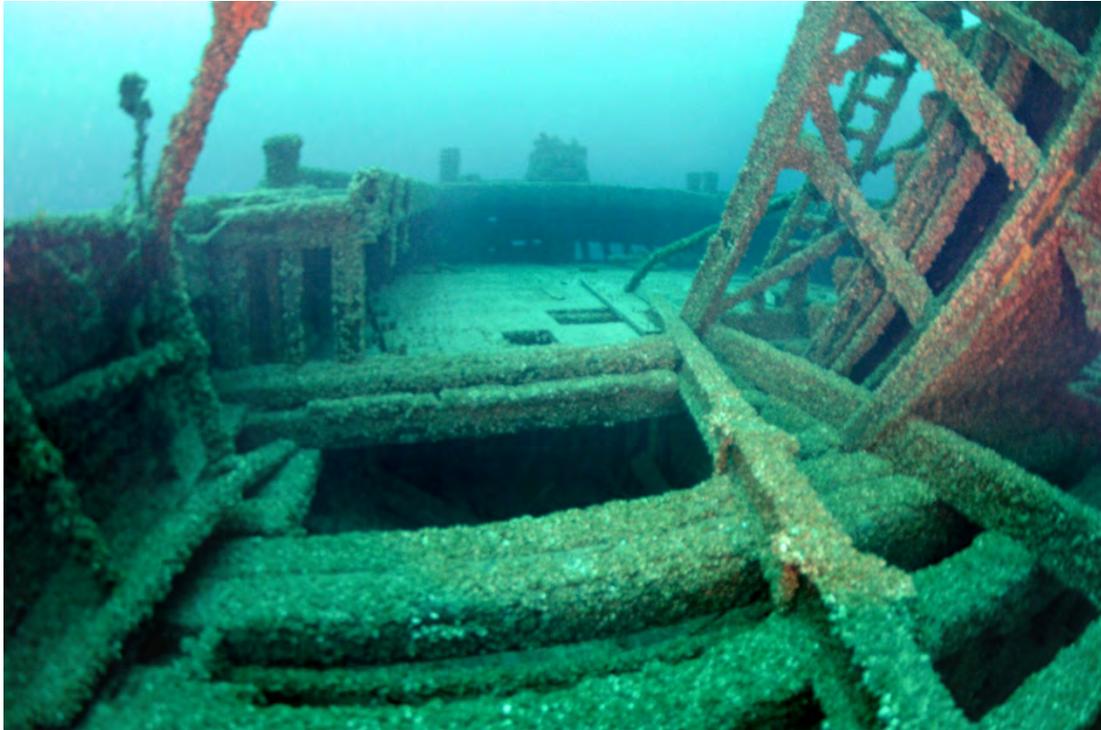
The stern cabin was removed during the vessel's conversion, but the cabin's coaming was left in place around the perimeter of the quarter deck (Figure 26). This coaming is 0.35 feet thick and is constructed of two timbers that are fastened back to back – the inner timber is 0.20 feet thick and the outer timber is 0.15 feet thick. The three extant sides of the coaming are 1.3 feet tall and rise 0.55 feet above the quarter deck. On the port side only, the upper, inside edge of the coaming is mortised for some type of frame or strongback. The three sides of the coaming vary somewhat in their height above the cabin sole, with the top of the coaming rising 4.85 feet on the starboard side, 5.15 feet on the port side, and 5.6 feet on the aft coaming.

Figure 26. Looking aft from the starboard side of the unloading tower.

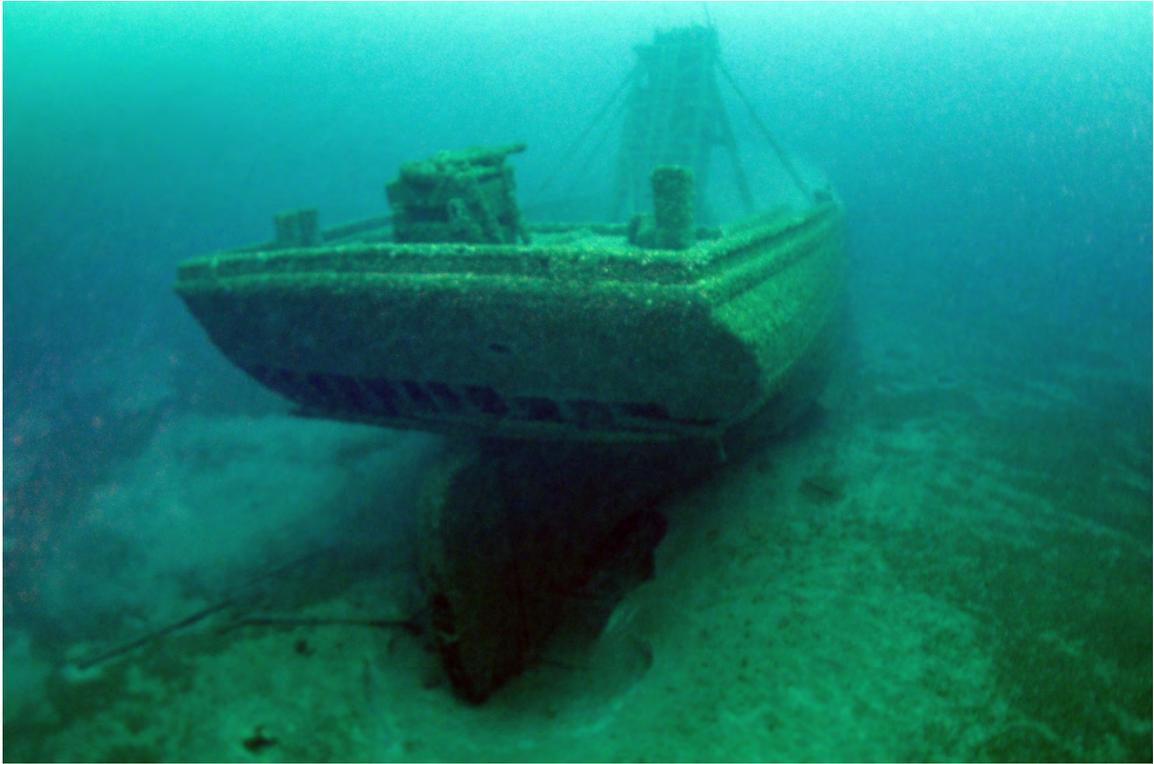
The transom is 21.3 feet wide and 10.6 feet tall (Figure 27). Two port lights were located in the transom, but only the port side light is extant. The port light is non-opening, with a 0.35 foot diameter glass housed in a brass ring with a 0.5 foot outside diameter. The rudder is completely exposed and reaches a water depth of 170. The rudder blade is 13.0 feet tall, 5.0 feet long at its widest point, and 1.2 feet wide.

Figure 27. The *EMBA*'s stern, viewed from off the starboard quarter.

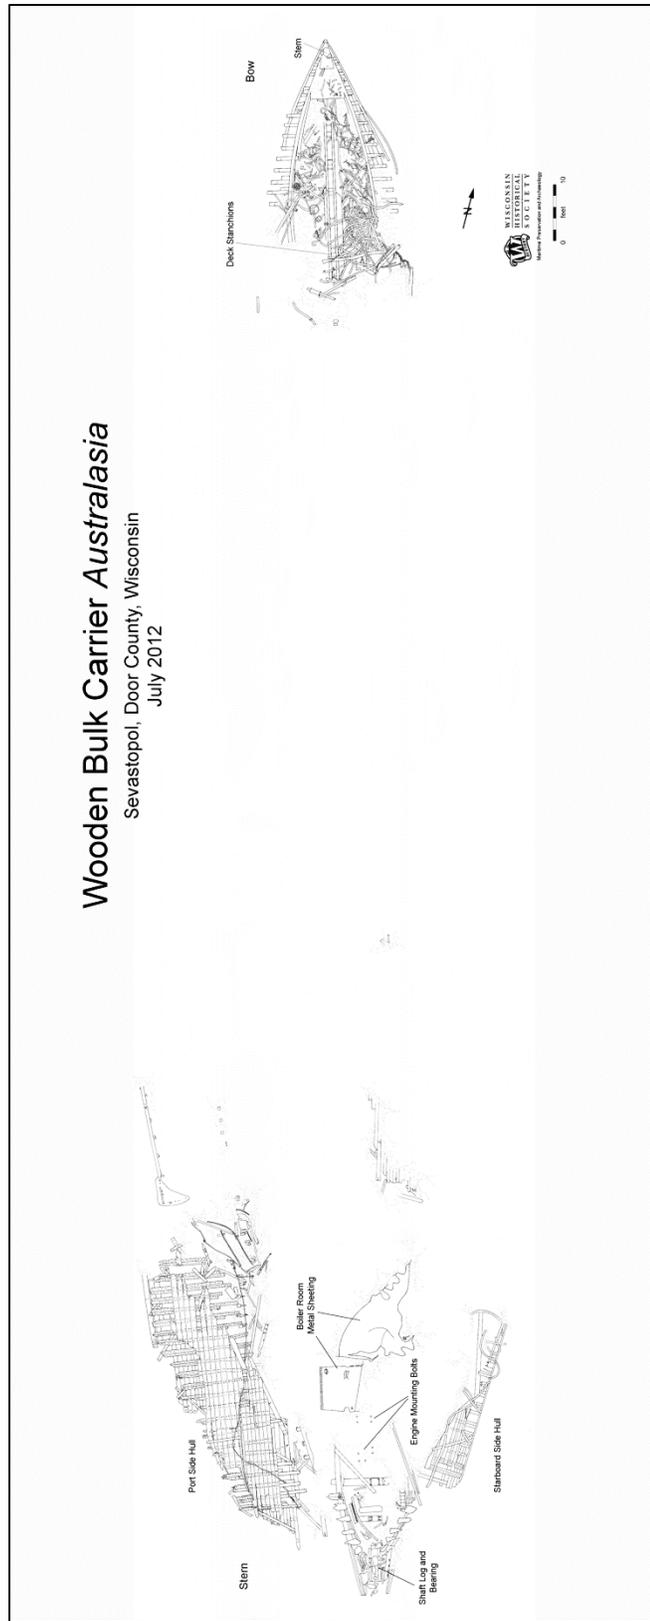
Figure 30. *Australasia* site plan.

A Phase II archaeological survey was conducted over 21-27 June 2012 to identify and record in plan view the overall underwater site while recording wreckage details for archaeological interpretation (Figure 30). Due to poor visibility at the time of the survey and the great distance between the bow and stern sections, two separate, temporary baselines were installed over either hull section to which all hull measurements were referenced. The two baselines were then referenced to one another in order to place each hull section on the overall site plan with proper placement and orientation.
